**LITTLE LEHIGH CREEK HYDRO-MODIFICATION,
STREAMBANK RESTORATION, HABITAT IMPROVEMENT
AND RIPARIAN PLANTING PROJECT**

July 2000

Wildlands Conservancy

Funding Provided By:
PA Department of Environmental Protection
Watershed Restoration and Assistance Program

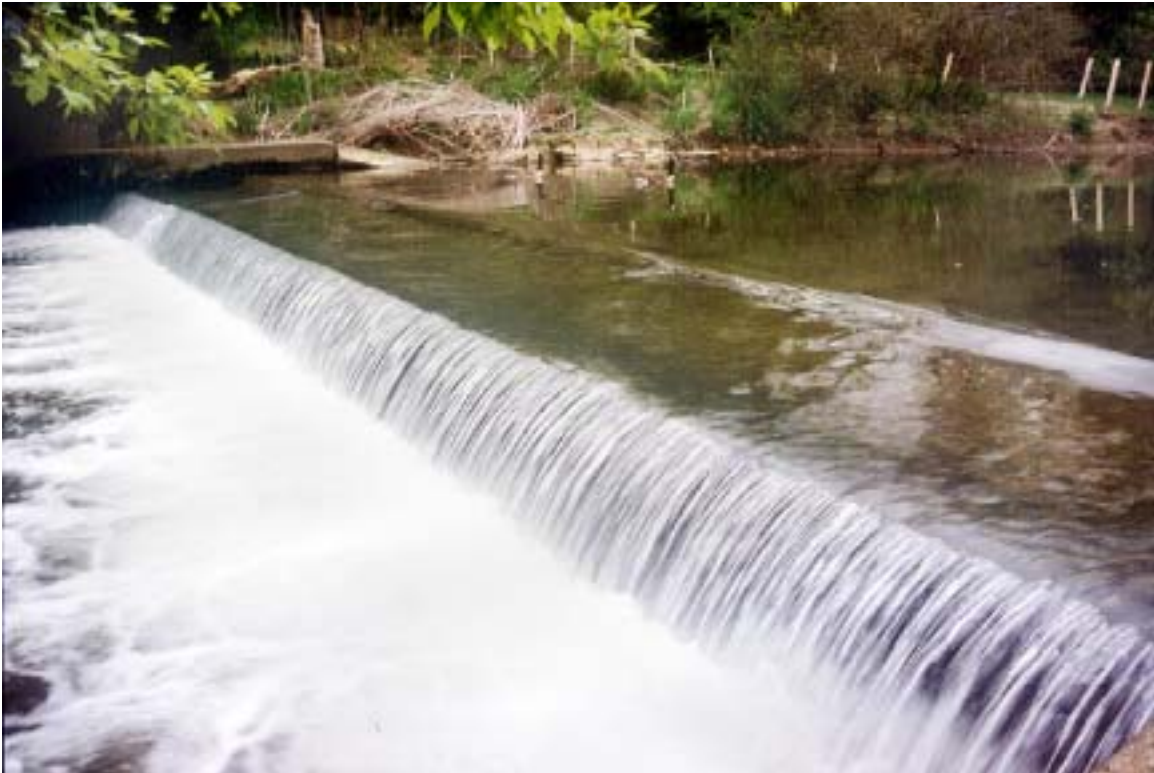
Figure 1. The run-of-the-river low-head dam located on the Little Lehigh Creek at Wildlands Conservancy's Pool Wildlife Sanctuary. The dam created negative environmental impacts and an unsafe situation for individuals utilizing the stream and adjacent property.

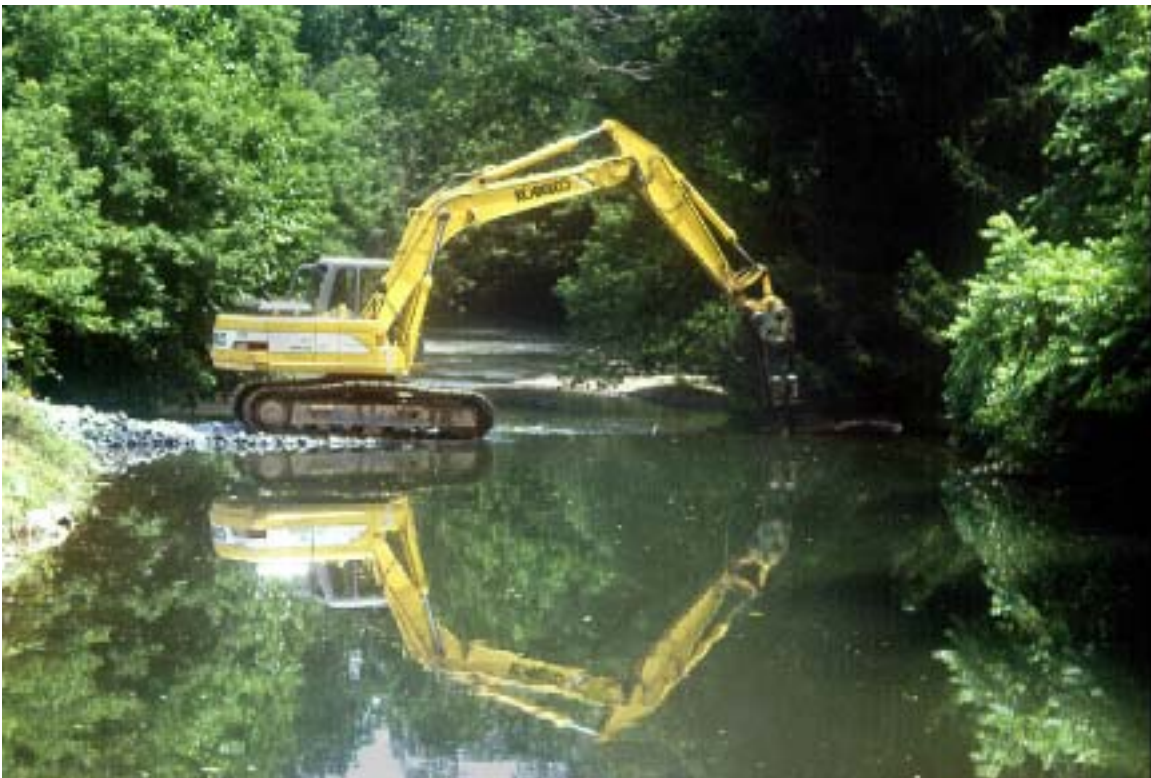
Figure 4. Once equipment access was established, a hydraulic jack-hammer was attached to the track-hoe and used to puncture the dam breast.

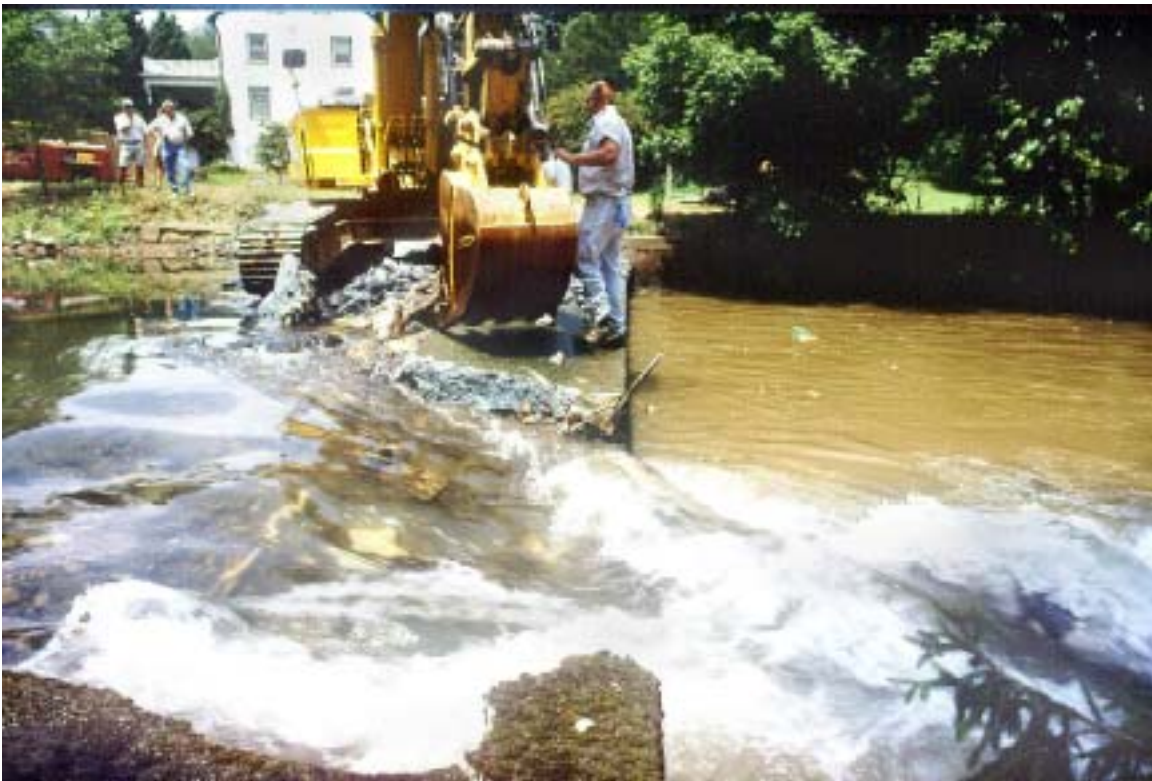
Figure 9. The dam breach excavation was paused periodically to assess the condition of the breach and allow a controlled draw down.

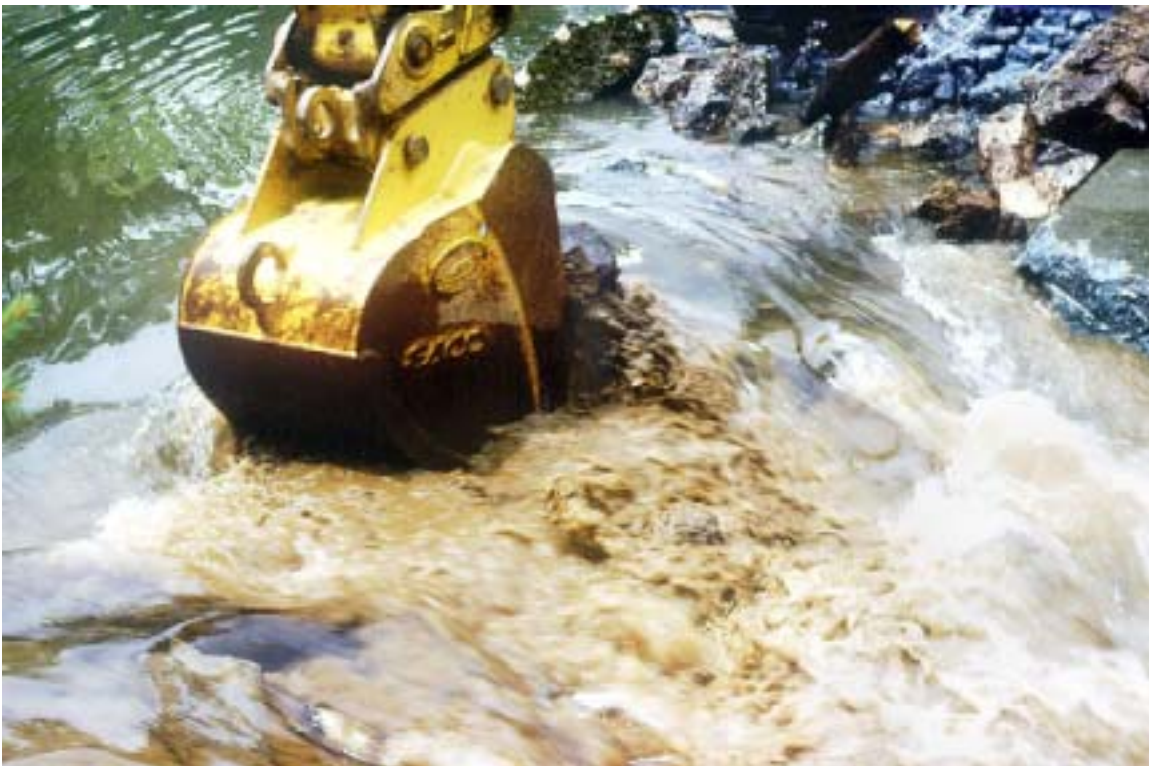
Figure 10. Removing the dam created a slight disturbance of the stream substrate within the project area. The long-term environmental benefits achieved by removing the dam should, however, negate this temporary disturbance.

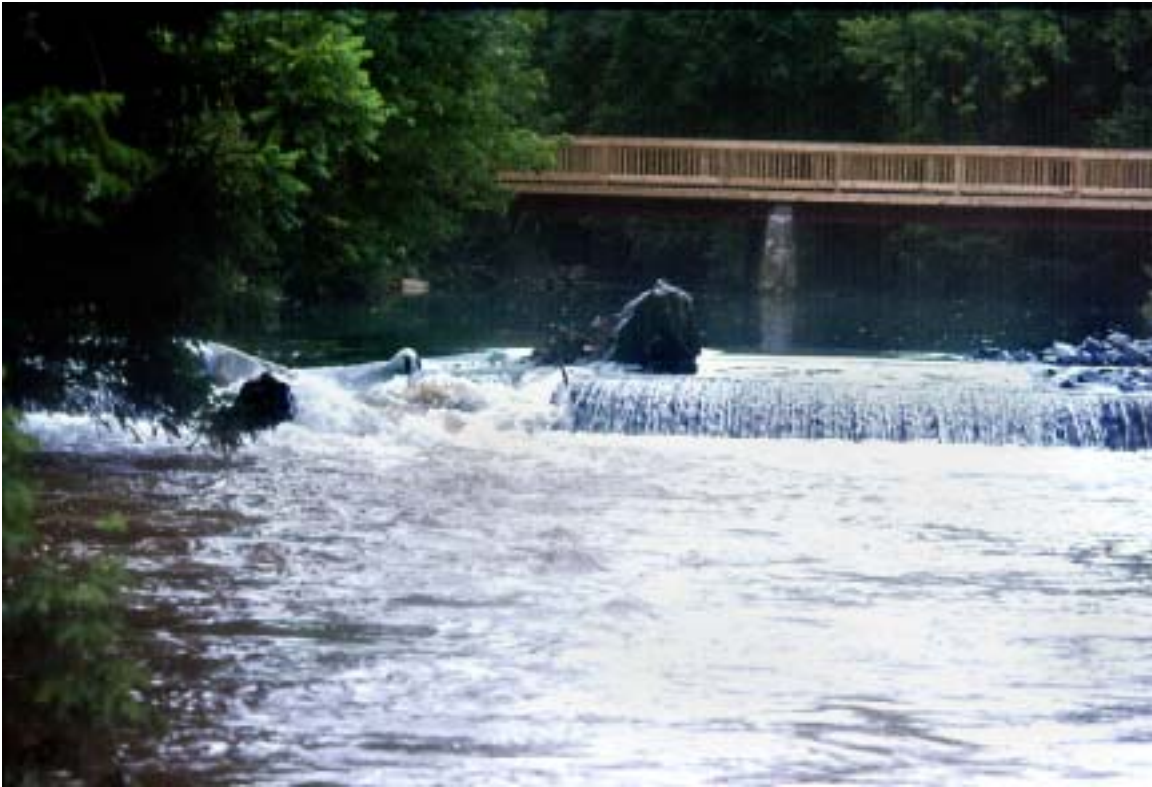
Figure 11. Breaching the dam caused a slow increase in the downstream water level by approximately three to four inches. The duration of this temporary rise in water level was approximately fifteen minutes and appeared to cause no negative downstream impact.

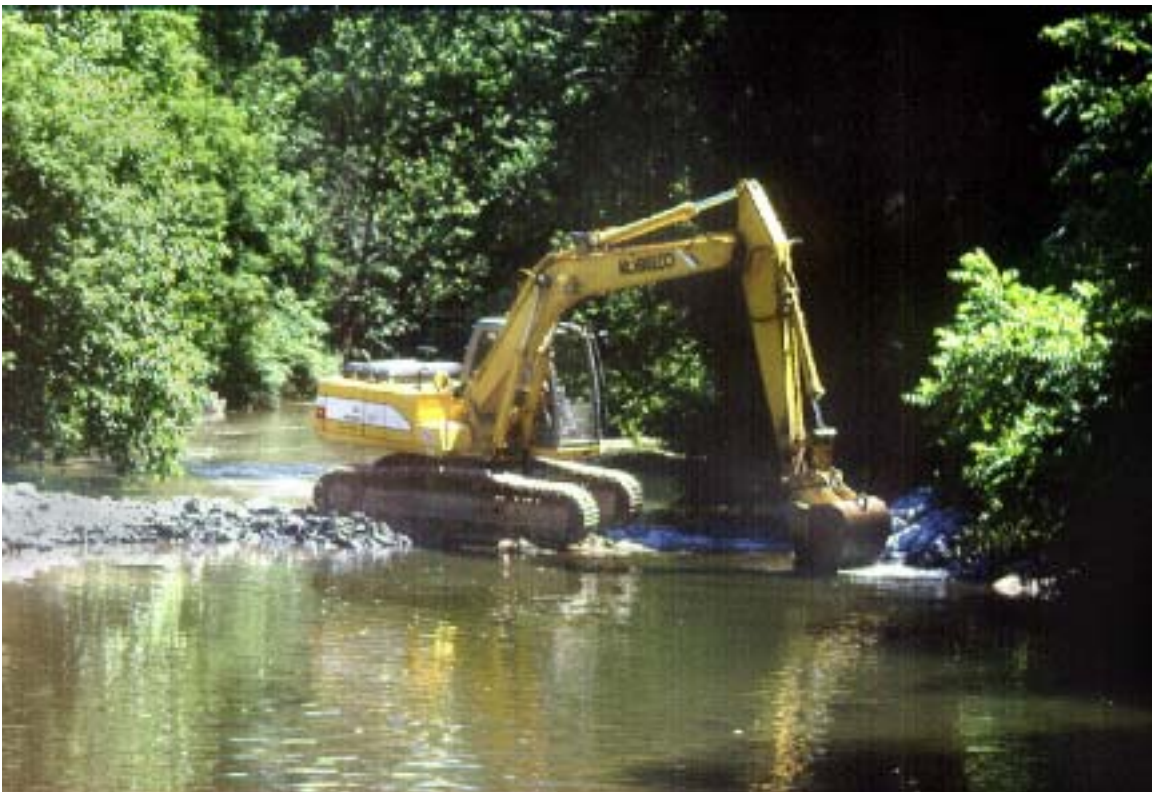
Figure 12. The opposite stream bank was stabilized with limestone riprap before the remainder of the dam was removed.

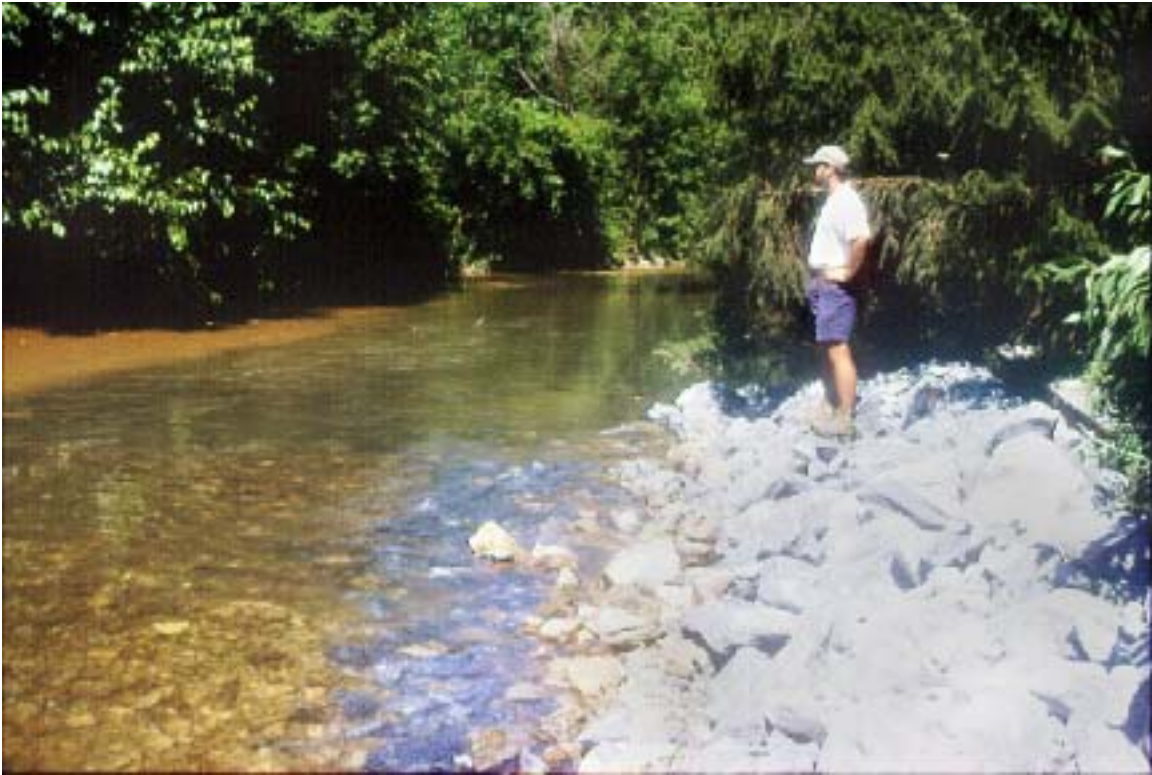
Figure 13. The stone that was used to stabilize the stream banks should vegetate and become camouflaged as sediment carried by the stream is deposited during storm events.

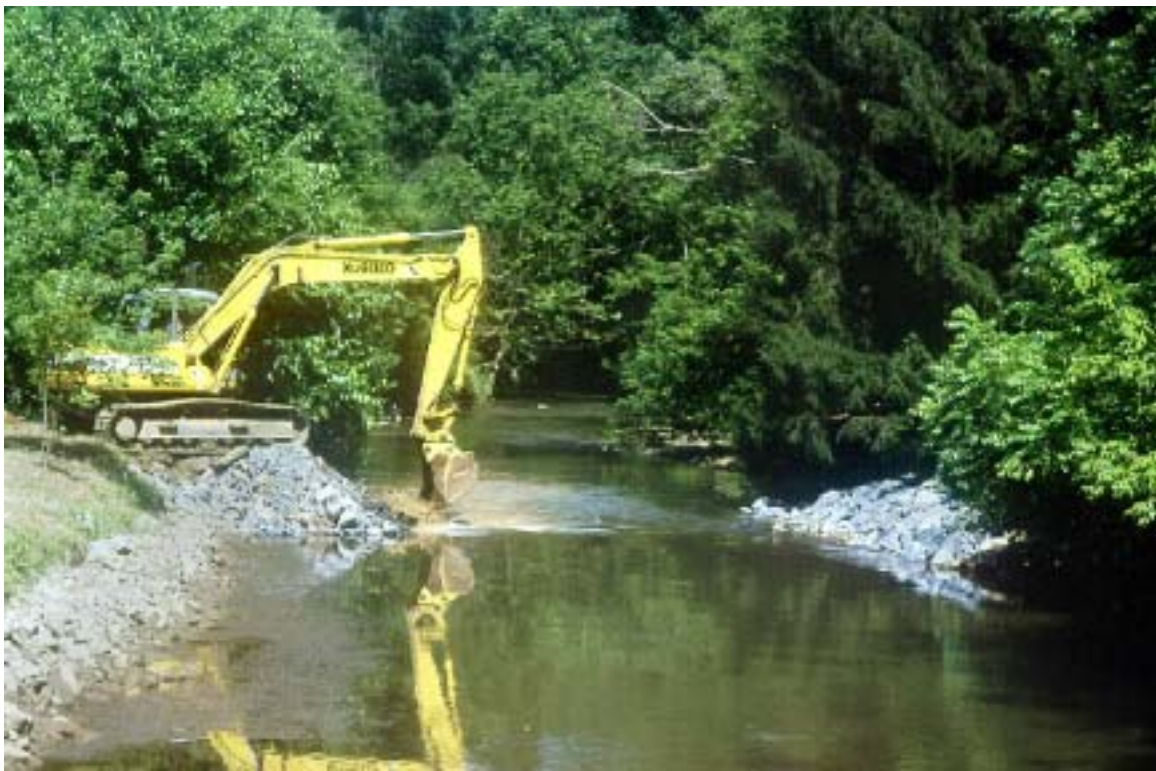
Figure 14. Once the opposite stream bank was stabilized, the remainder of the dam was removed. The stone causeway was then removed and used to provide stone to stabilize the near stream bank.

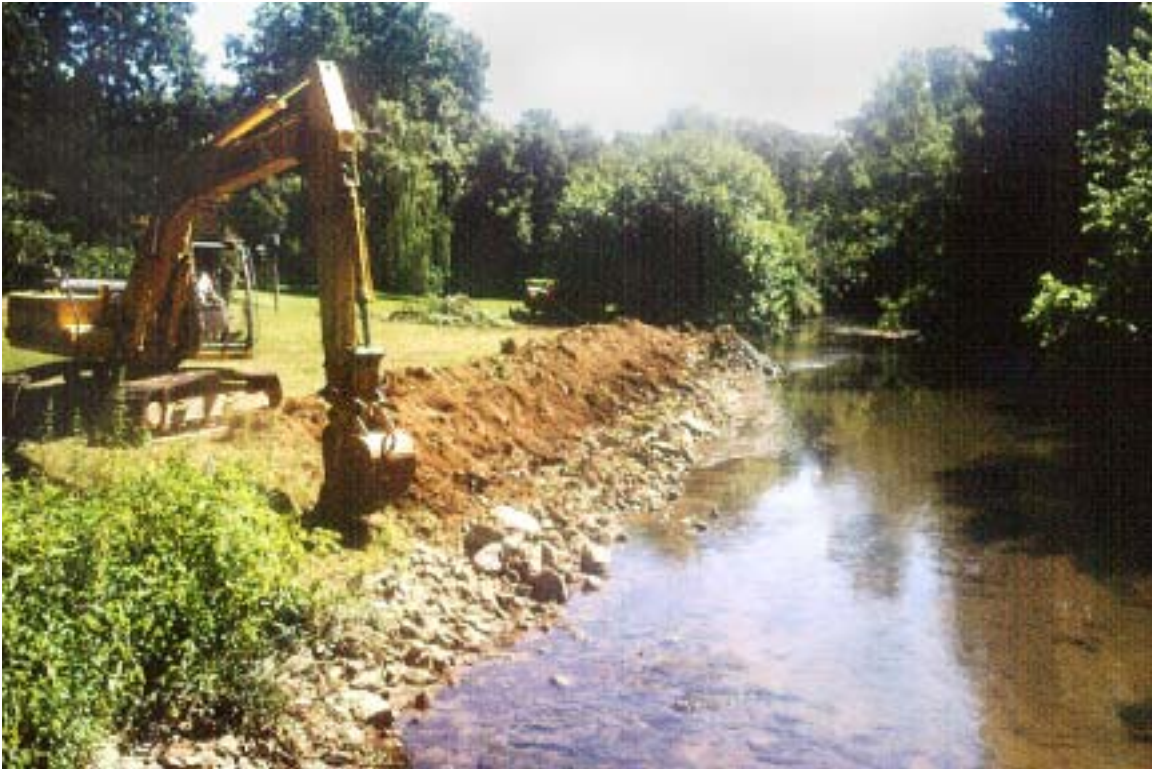
Figure 15. A concrete retaining wall approximately 190 feet in length was removed before creating a grade transition from the top of the bank to the streambed.

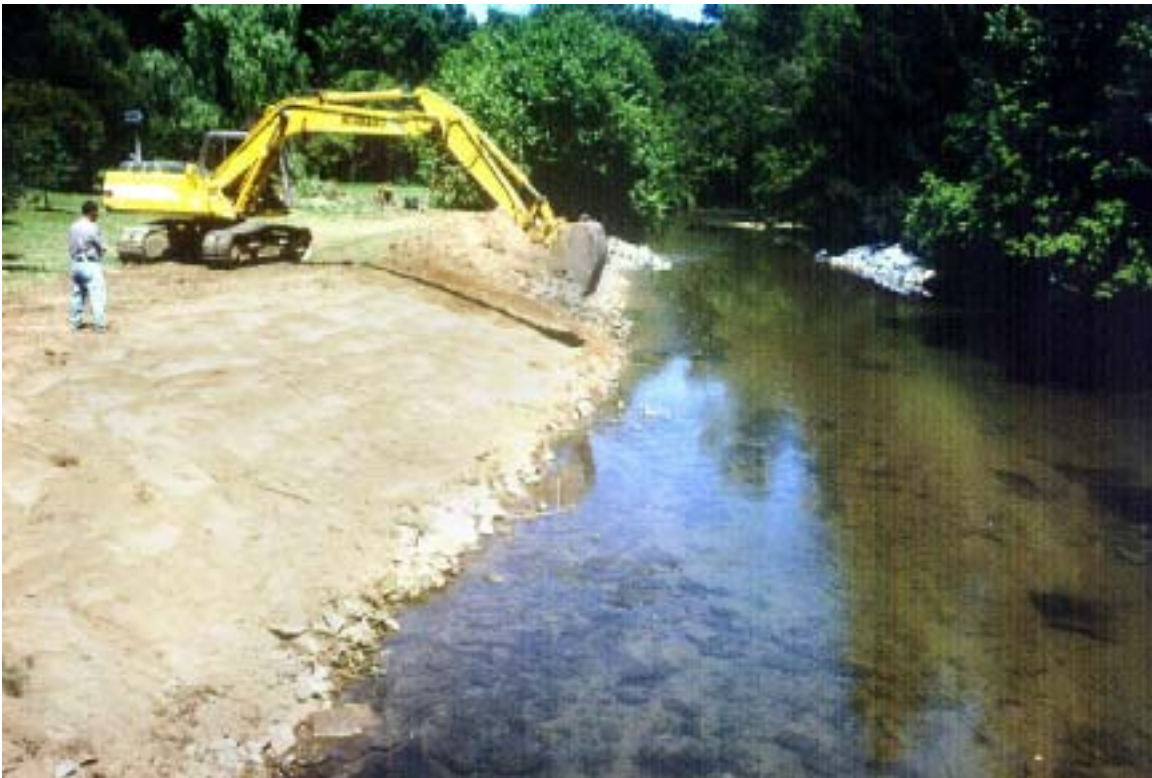
Figure 16. Once the concrete retaining wall was removed, the stream bank was graded to an approximate 3:1 grade. This grade will allow stream bank vegetation to become established. Impacts were minimized during bank grading by drawing soil away from the stream.

Removing the concrete retaining wall allowed for the grading of this stream bank to an approximate 3:1 grade (Figure 16). After grading was completed, facultative wetland meadow mix and turf grass seed was applied to the soil. Biodegradable erosion control blanket was rolled out along the graded bank and secured using biodegradable stakes (Figure 17). Two stone paths were incorporated into this bank to provide education groups access to the stream (Figure 18).

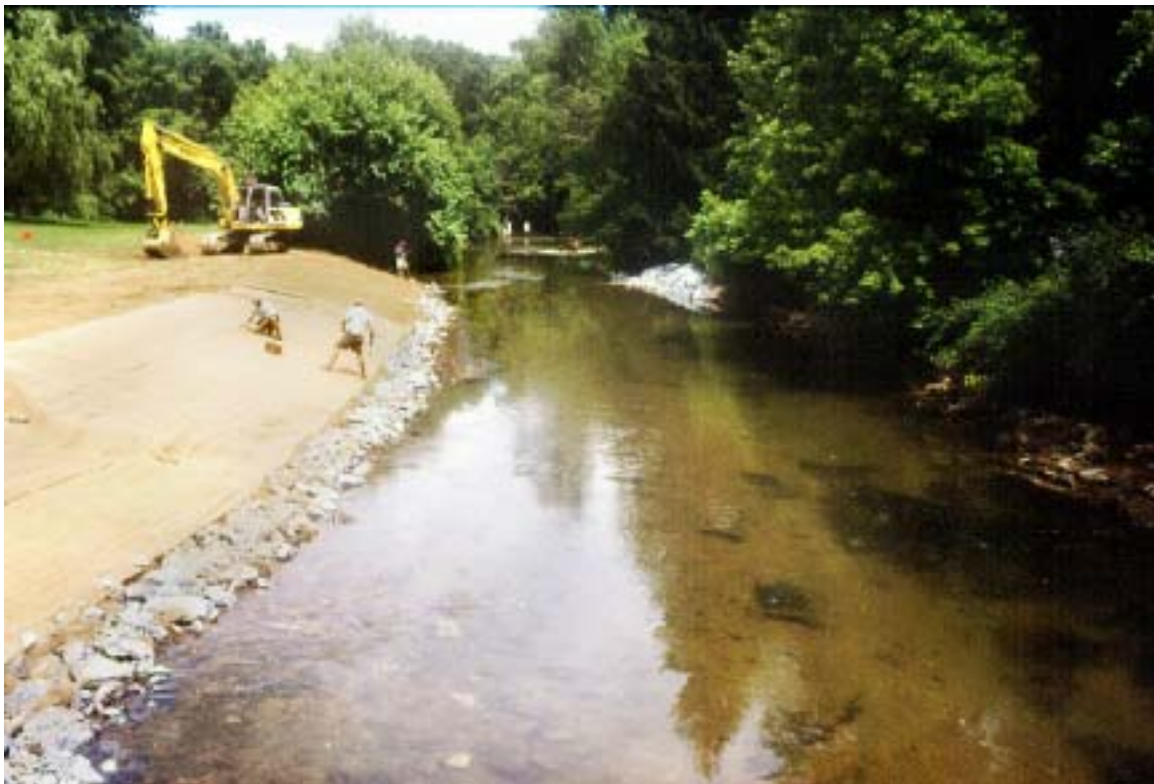
Figure 17. After stream bank grading was completed, stone riprap was placed along the toe of the stream bank to provide bank stability. Two access paths were excavated before applying biodegradable erosion control blanket along the length of stream bank.

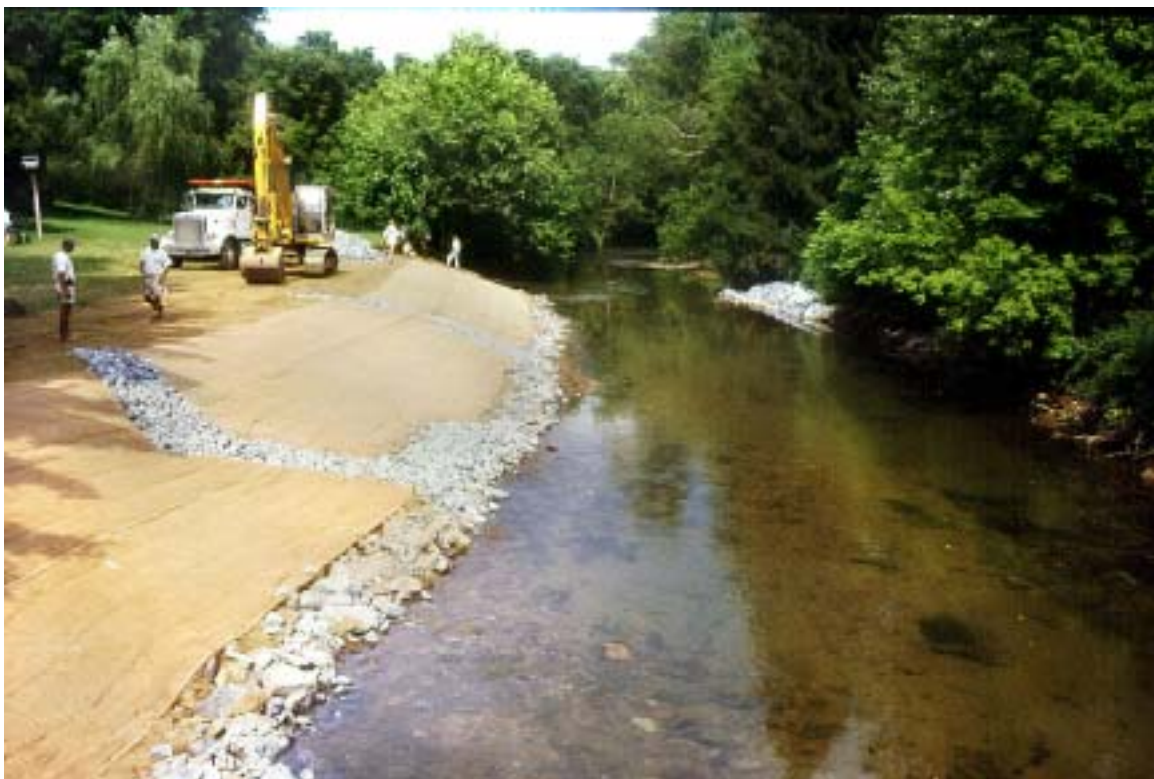
Figure 18. The erosion control blanket was secured to the stream bank using biodegradable stakes. Access paths were installed to provide access for educational groups utilizing the stream corridor.

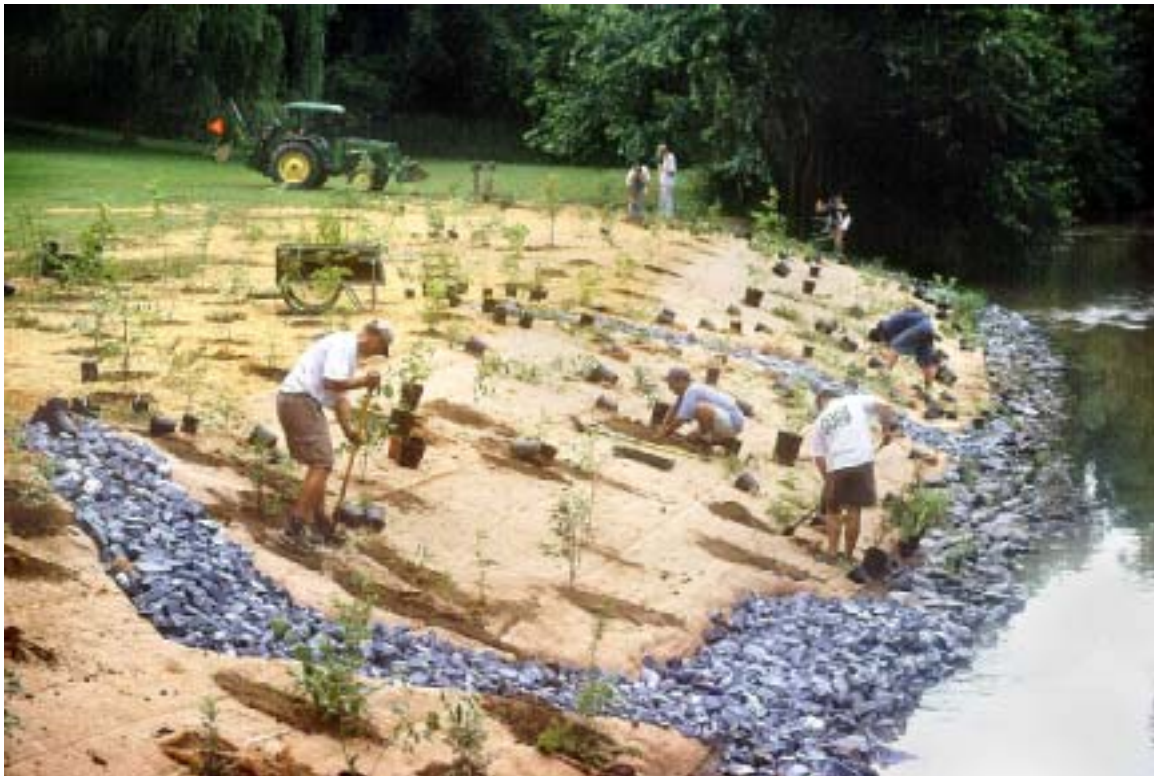
Figure 19. Several varieties of native trees, shrubs and herbaceous material were planted to establish a riparian buffer along this section of the Little Lehigh Creek. This vegetation will minimize soil erosion and provide shade to the stream, maintaining the cool stream temperature essential to fish and macro-invertebrate survival. Stream bank vegetation offers habitat for wildlife and serves as a buffer, protecting the stream from the negative impacts associated with land uses such as agriculture and urban development.

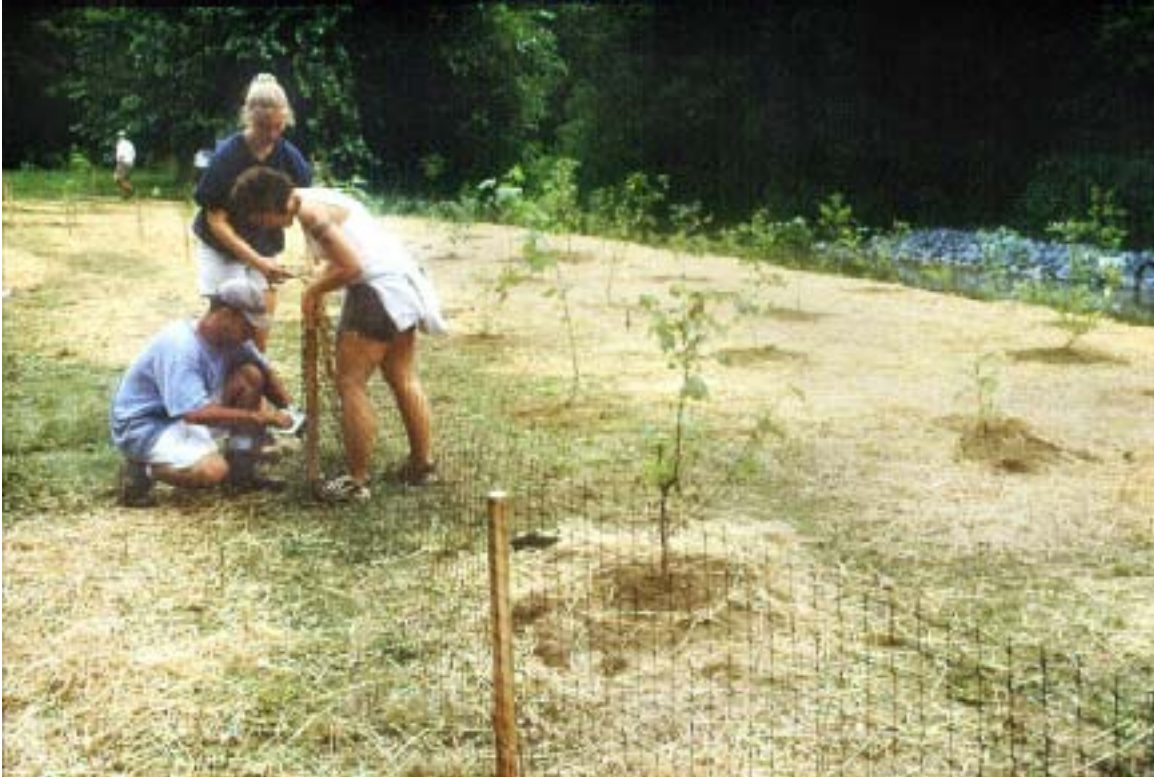
Figure 20. Once the vegetation was planted, exclusion fencing was erected to deter waterfowl access to the site and ensure growth. The fencing will be removed once the newly planted grass seed and vegetation becomes established.
