**TRIBUTARY TO MONOCACY CREEK
STREAM RESTORATION PROJECT**

July 2000

Wildlands Conservancy

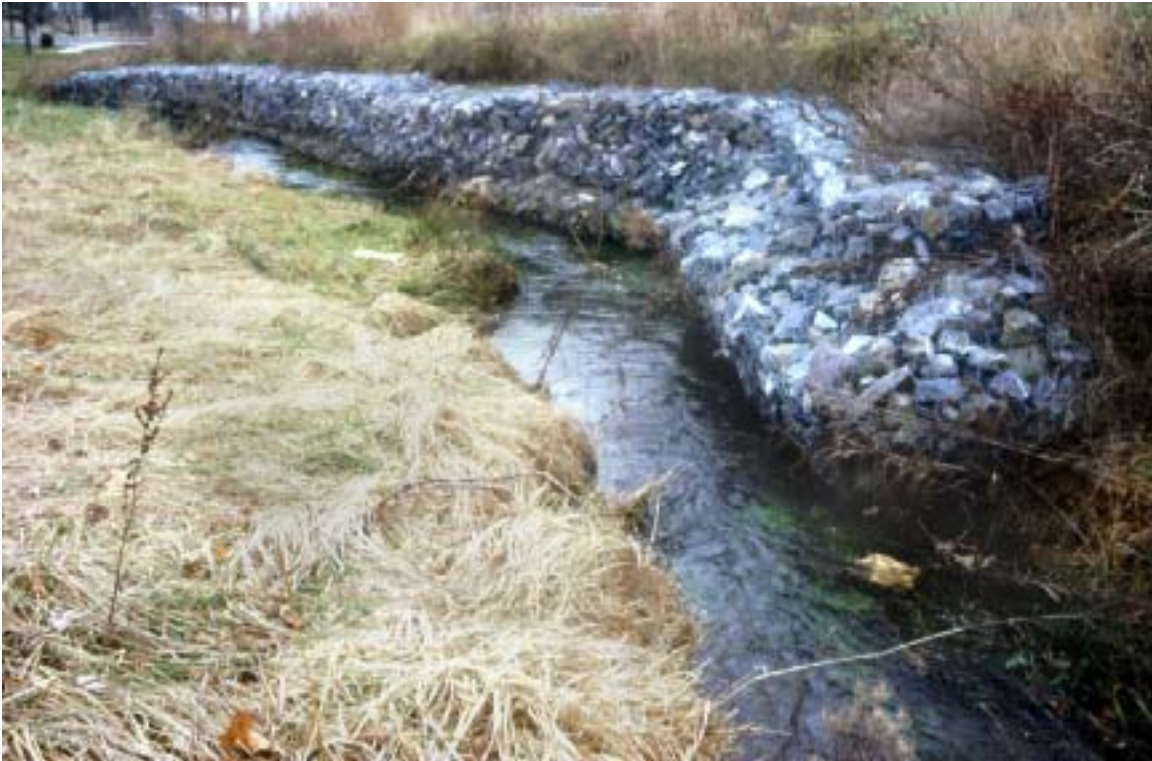
Figure 1. Gabion baskets have channelized a portion of the stream reach within Keystone Park. Stream channelization, urban storm water and a lack of riparian vegetation have impacted this reach by accelerating bank erosion and sedimentation.

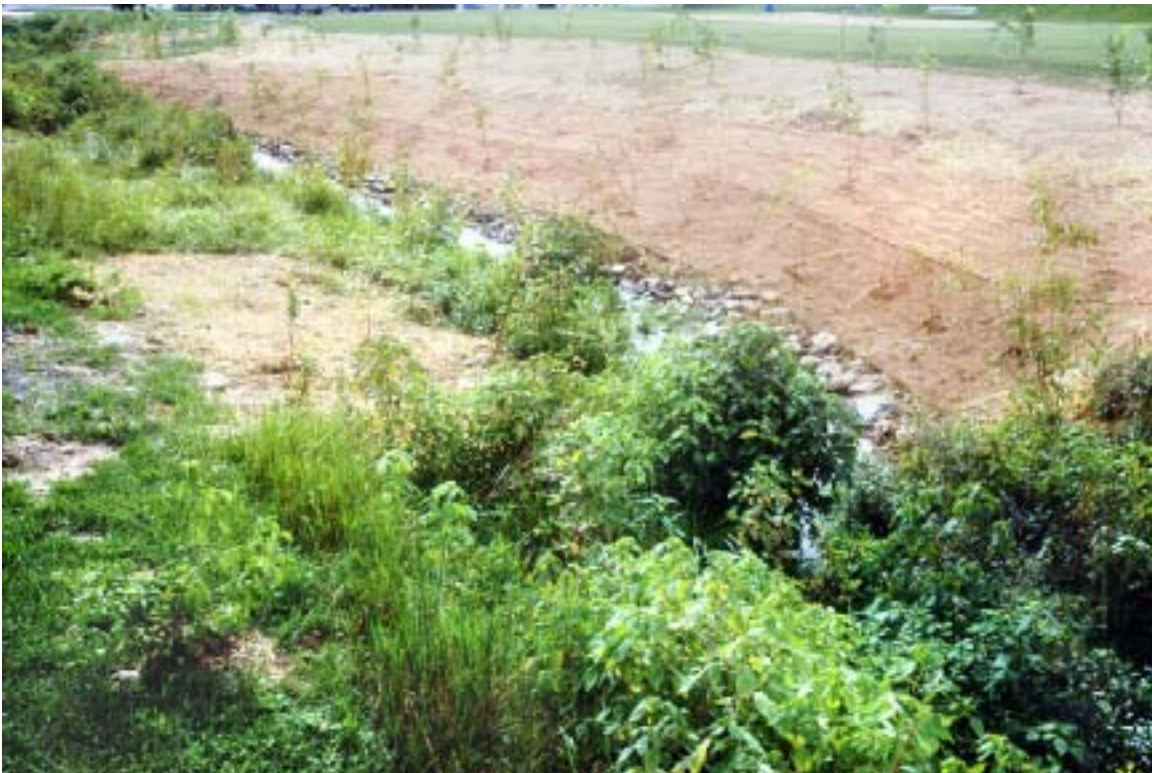
Figure 4. A graded stream bank allows for the establishment of riparian vegetation that will provide stabilization and habitat within the stream corridor.

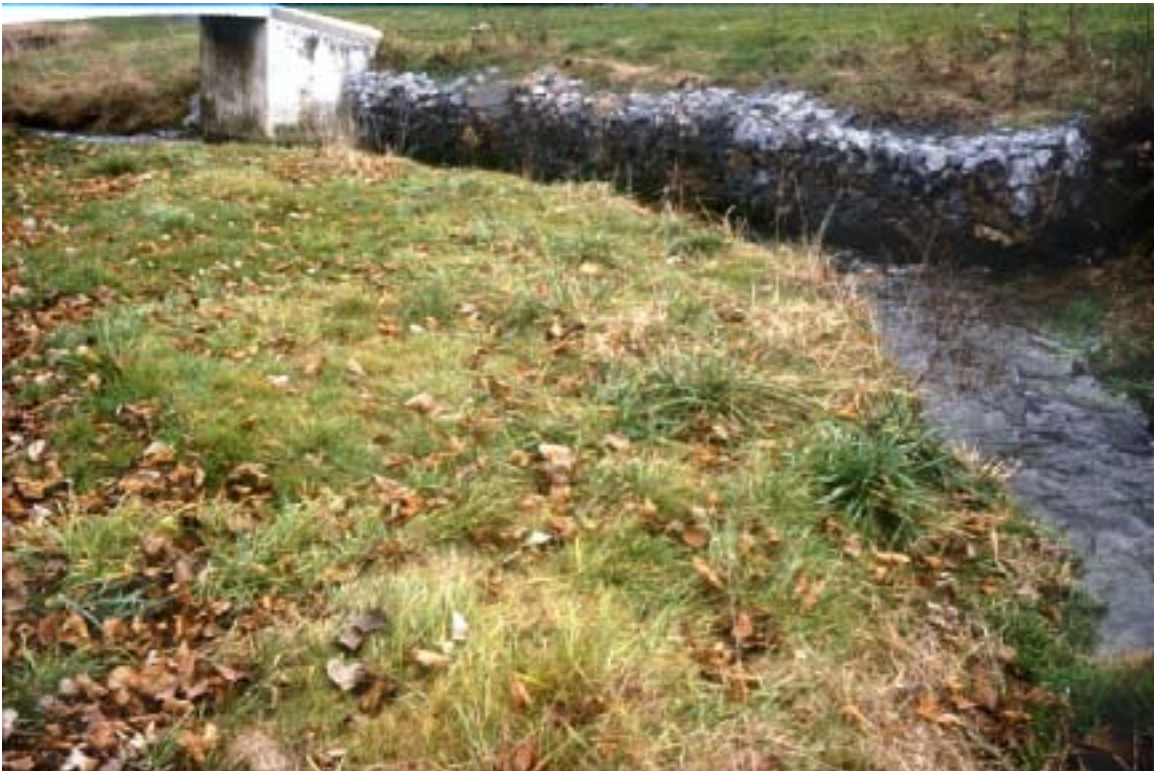
Figure 5. Gabion baskets within the park were structurally failing and offering little opportunity for the establishment of bank vegetation. Before the project was implemented, grass was mowed to the edge of the stream banks.

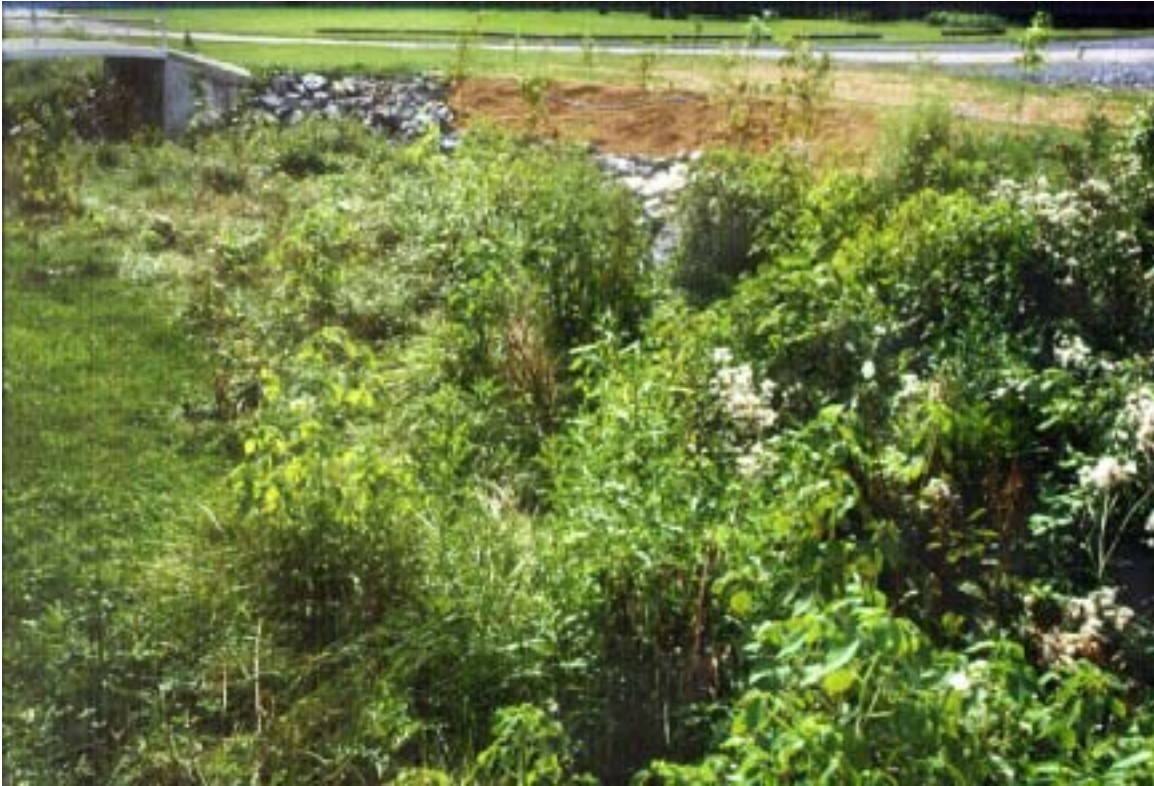
Figure 7. Stream bank vegetation became established quickly after recommendations to establish a no-mow zone were adopted.

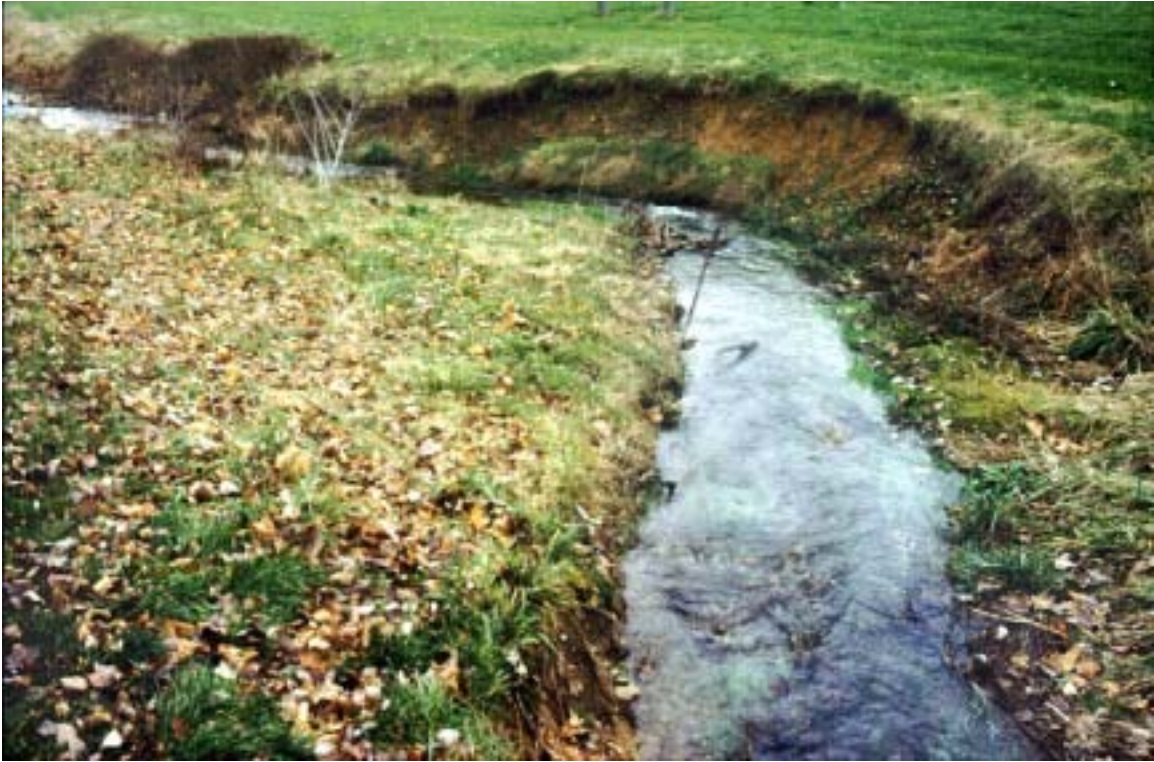
Figure 10. Bank erosion was most severe along stream banks that were situated along the outside of meander bends. Shallow rooted grasses offer little stabilization value. These banks would require more intensive techniques to stabilize and revegetate.

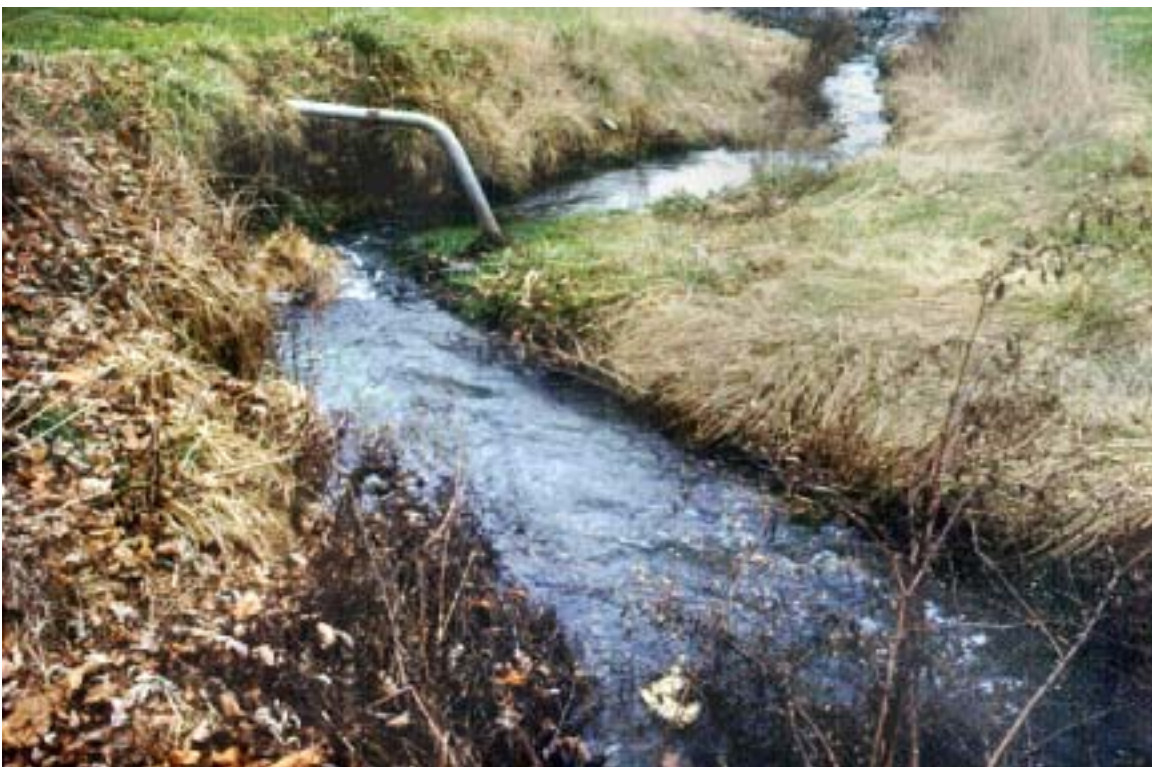
Figure 18. This picture illustrates the tendency of the stream to meander in time, thus exposing an electric line that was once buried in the stream bank.

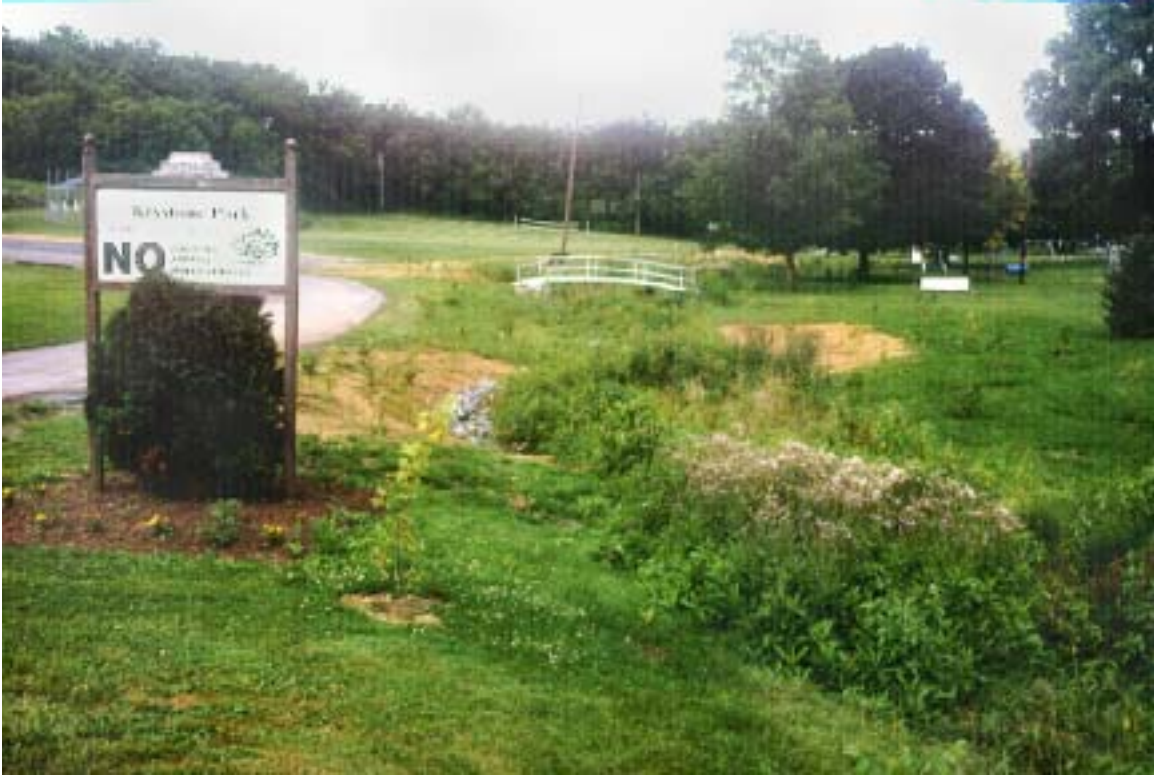
Figure 20. An upstream view of Keystone Park, following project completion. This project should improve the water quality of the Monocacy Creek and will serve as a valuable example to other municipalities facing similar stream corridor management challenges.
