LITTLE LEHIGH CREEK
STREAM RESTORATION PROJECT

1999

By: Wildlands Conservancy

INTRODUCTION

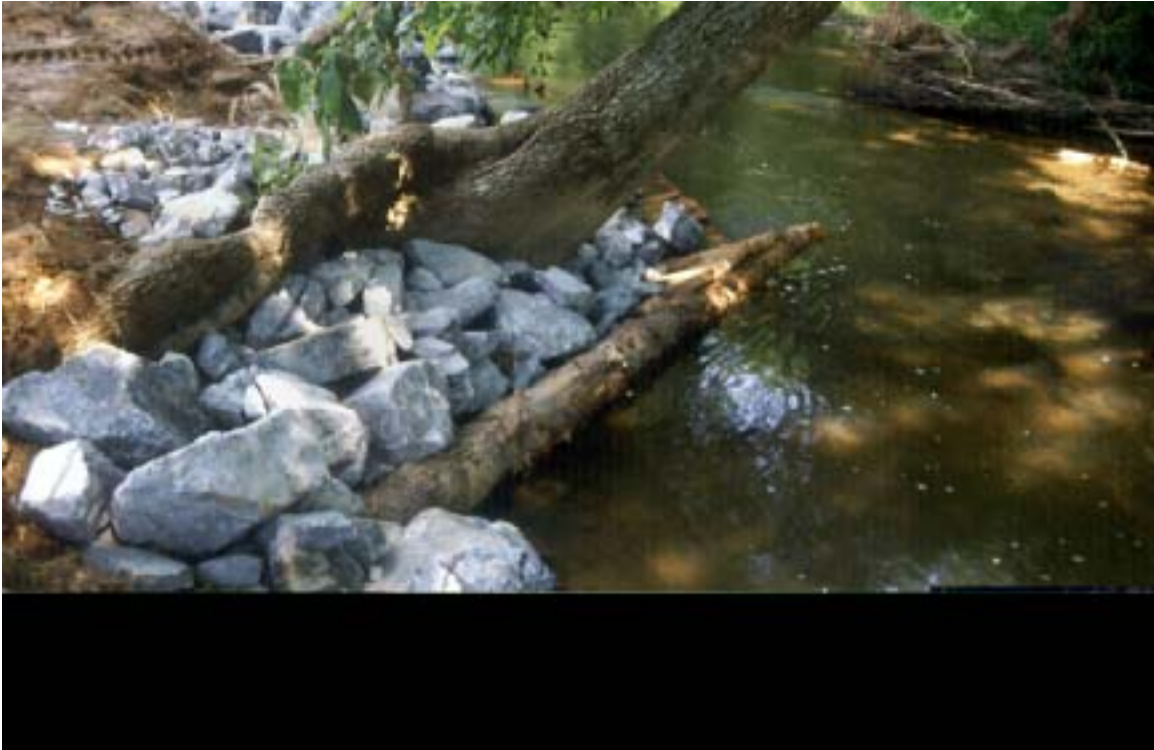
Figure 1 – A stacked deflector with oak flooring provides overhead cover for fish and narrows the stream channel.

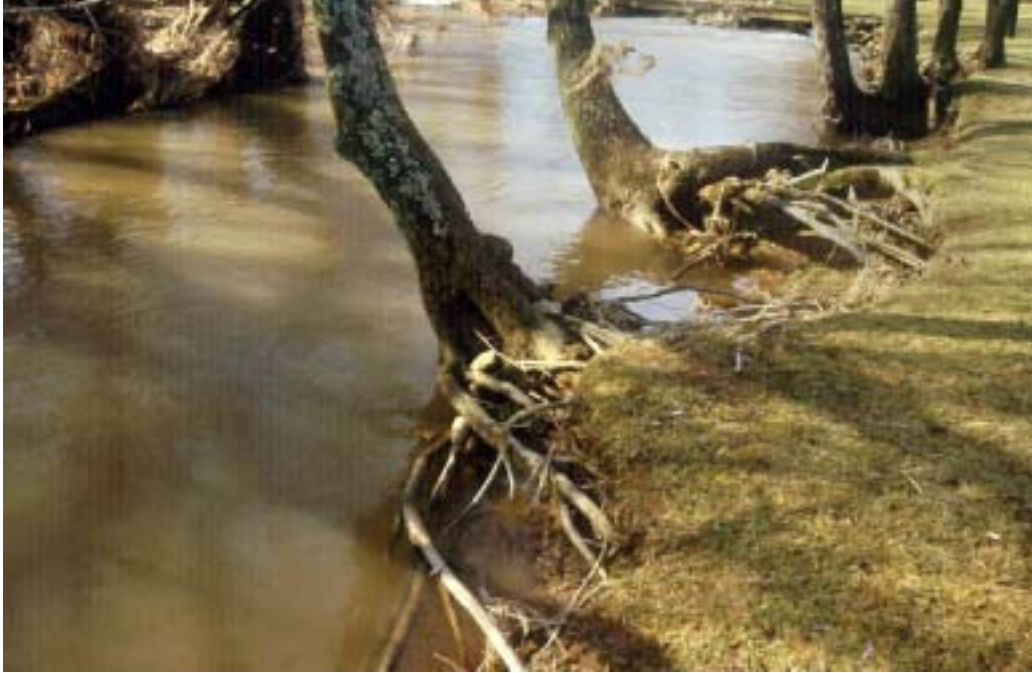
Beginning at the 265' mark, modified bank cribbing was constructed to stabilize a length of severely eroded stream bank while offering overhead cover for fish (Figure 2). This cribbing (approximately 60 feet in length and 5 feet in width) was filled with stone and tapered into the bank with an approximate 3:1 grade (Figure 3). A well-defined channel of *slightly* increased velocity should develop along the face of the cribbing, facilitating the transport of fine sediment off of the more desirable stream bottom substrate (cobble and gravel) improving macro-invertebrate habitat. Similar to the

Figure 2 – Proposed site of modified bank cribbing. Note the severely eroded stream bank and lack of in-stream habitat.

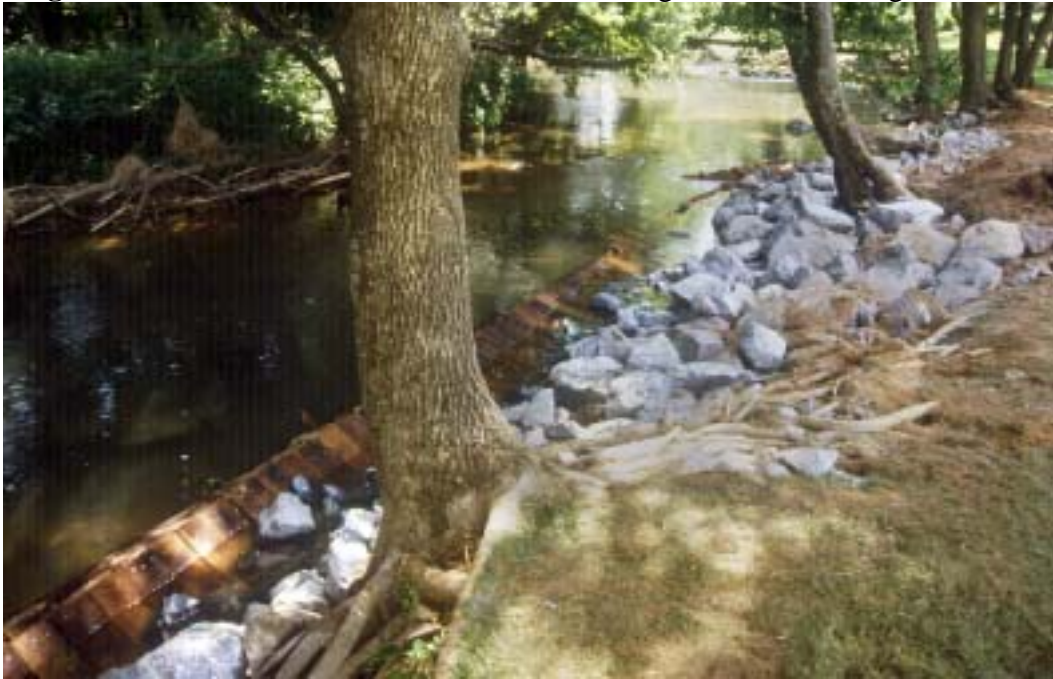
Figure 3 – Construction of modified bank cribbing with oak flooring and stone.

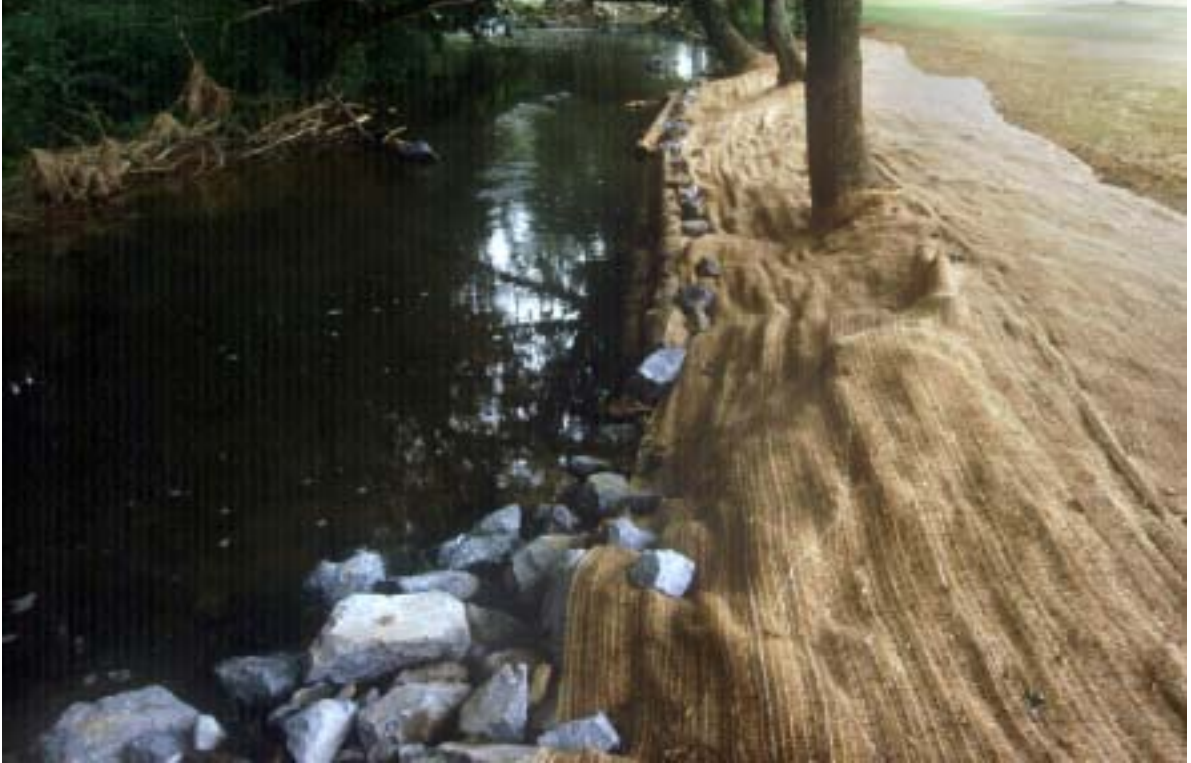
Figure 4 – Modified bank cribbing with seeded jute matting. Jute matting minimizes future soil erosion and provides moisture retention essential to the development of newly planted seed.

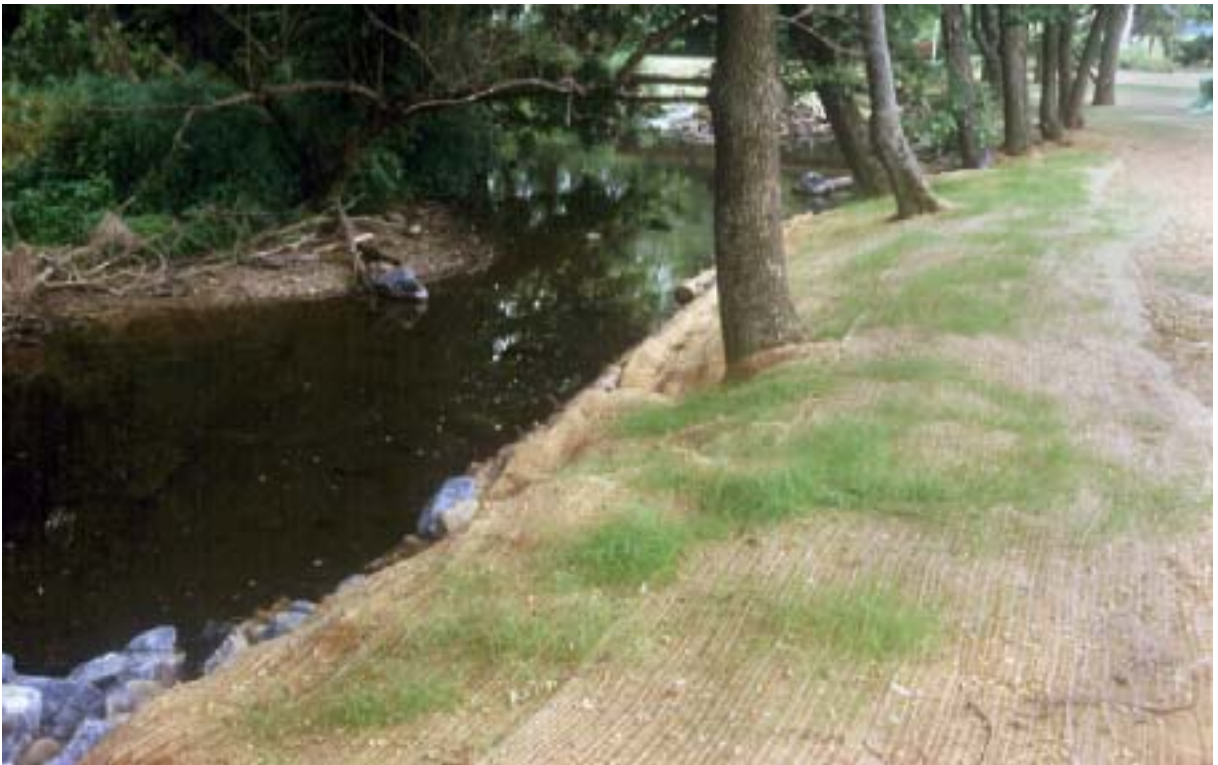
Figure 5 – Modified bank

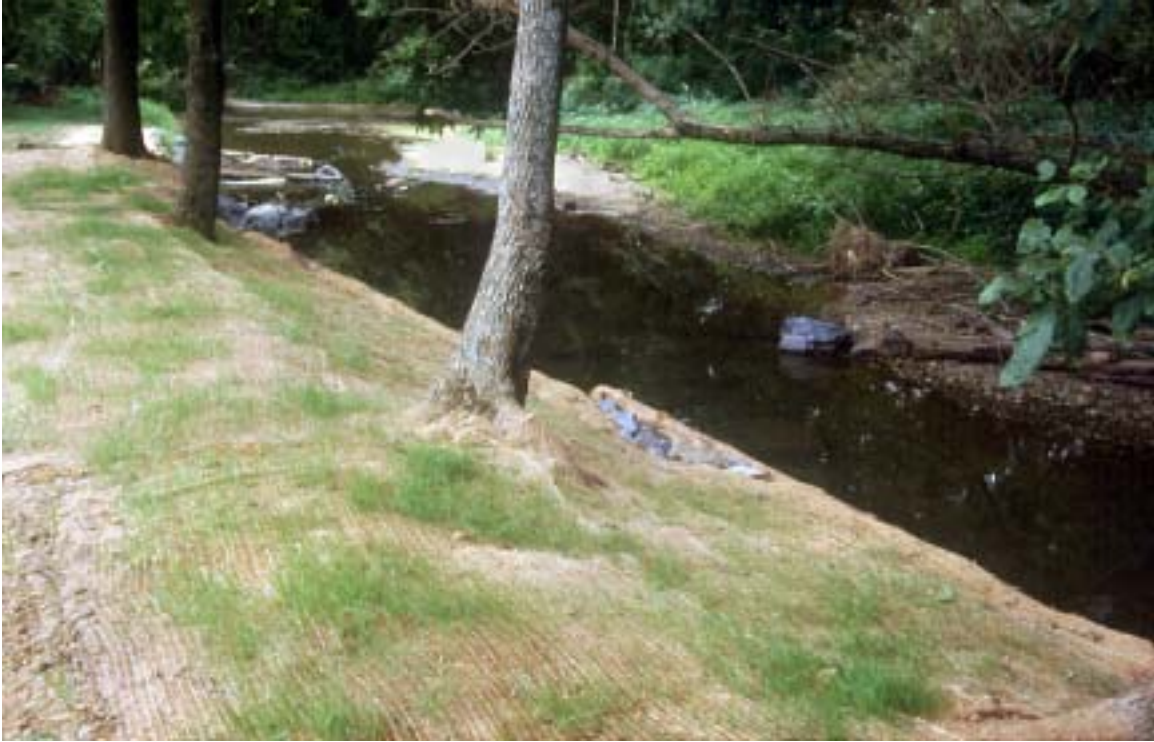
Figure 6 – Modified bank cribbing with seeded jute matting one month after construction. A stable undercut bank has been established. The grass will provide future stability to the stream banks during high flow.

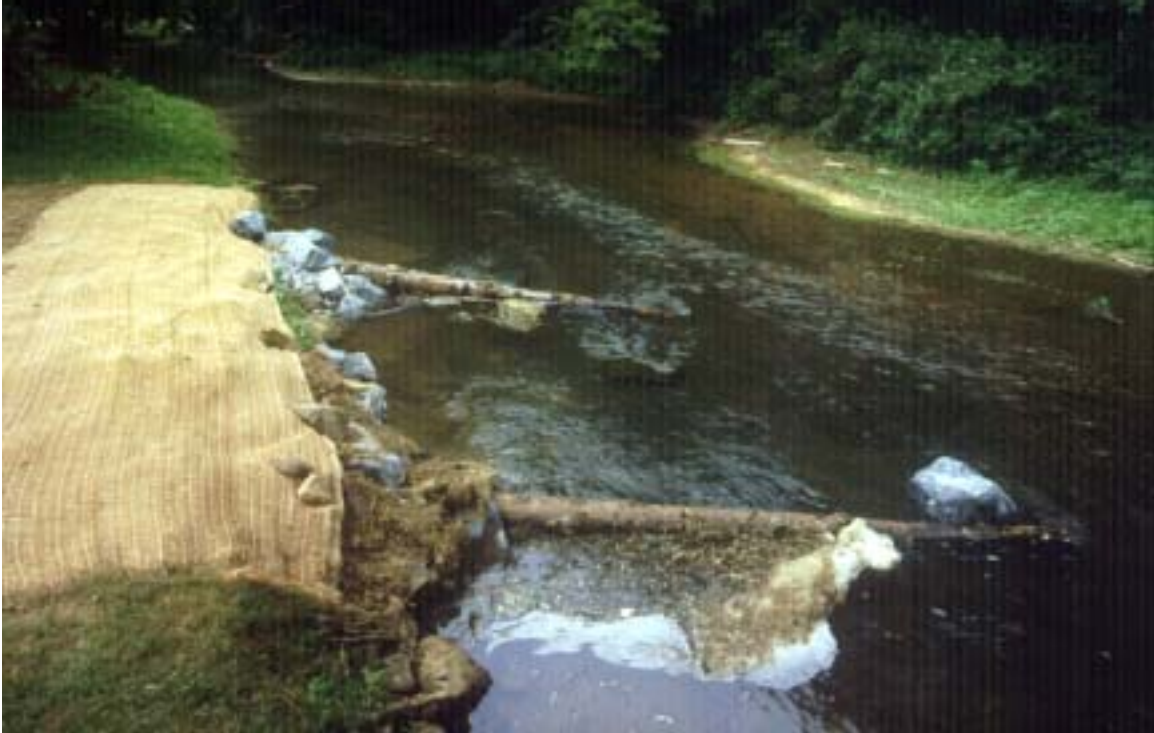
Another type of device used to provide naturalistic habitat for fish and aquatic macro-invertebrates is an upstream single log. Two upstream single logs were placed at the 360' and 372' marks and secured to the stream banks using stone. These logs were situated at an upstream angle (approximately 30 degrees relative to bank) and tilted to allow the tips of the logs to rest on stream bottom. Since water typically falls off of objects at a 90-degree angle, placement of logs in this fashion should direct flow away from the stream bank and toward the center of the stream channel, as would a deflector. By doing this, both logs stabilized approximately 30 linear feet of stream bank. In addition to deflecting water, these devices should offer additional cover by scouring a pool in the vicinity of the log and mimicking natural woody habitat (Figure 7).

Figure 7 – Placement of upstream single logs deflects water from an eroded stream bank and provides naturalistic woody habitat for fish and aquatic macro-invertebrates. A scour pool will develop around the tips of the logs, offering overhead cover for fish.

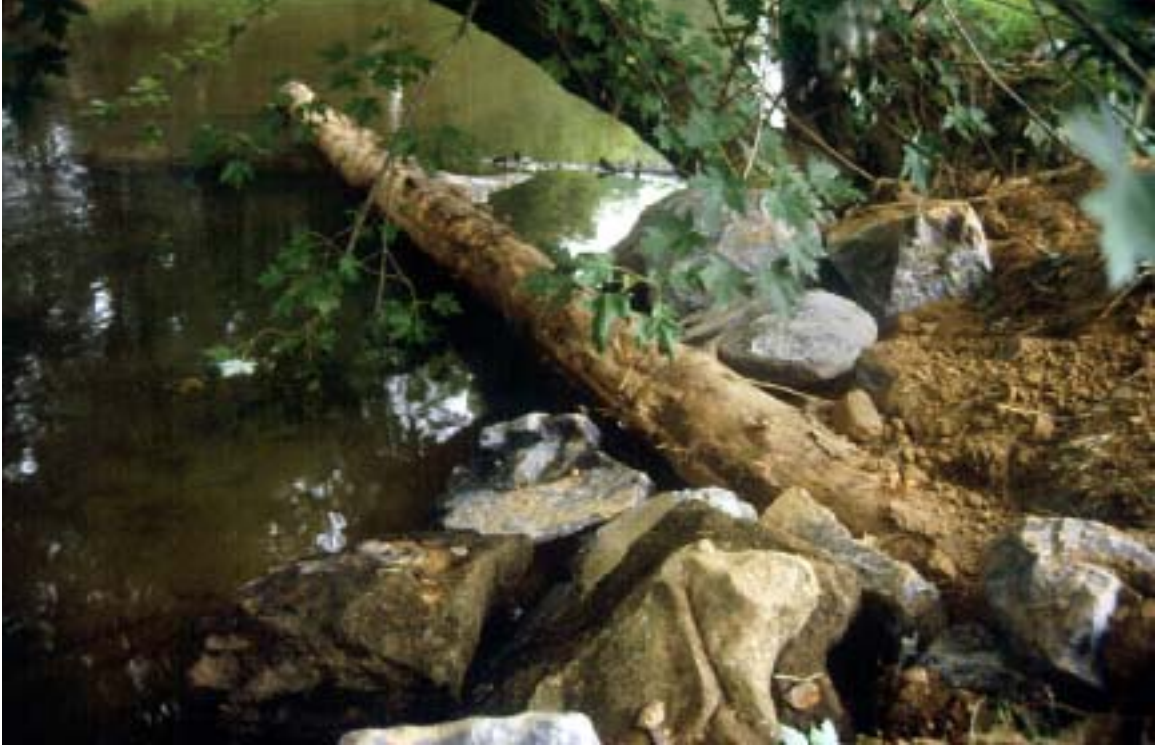
A multi-log deflector, consisting of two logs and stone, was constructed at the 507' mark to address an eroded length of bank in which a large tree was threatened. In the construction of this device, two logs were crossed and pinned to one another using 2' re-bar (reinforcement rod) and secured in the stream banks using stone. The upper most (top) log was angled upstream (similar angle as upstream single logs) and tilted downward from the stream bank to the tip of the log. This device should function similar to an upstream log in directing the flow of water away from the stream bank (and threatened tree) and toward the center of the stream channel. This device stabilized approximately 20 linear feet of stream bank and should also provide fish habitat by imitating natural woody debris (Figure 8).

Figure 8 – Placement of a multi-log deflector directs water away from a severely eroded stream bank and imitates the woody habitat that was previously lacking in this section of the Little Lehigh Creek.

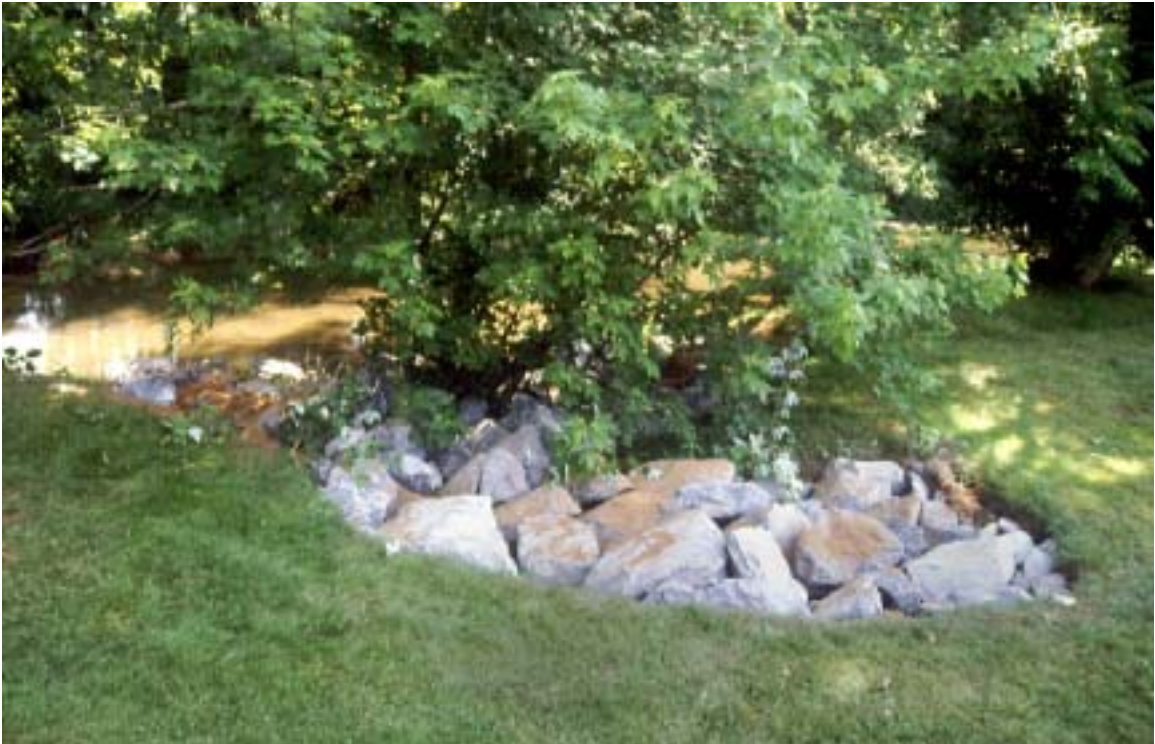
Figure 9– Stone was used to stabilize this eroded area adjacent to the multi-log deflector. The area was contributing silt to the stream and was negatively impacting aquatic habitat.

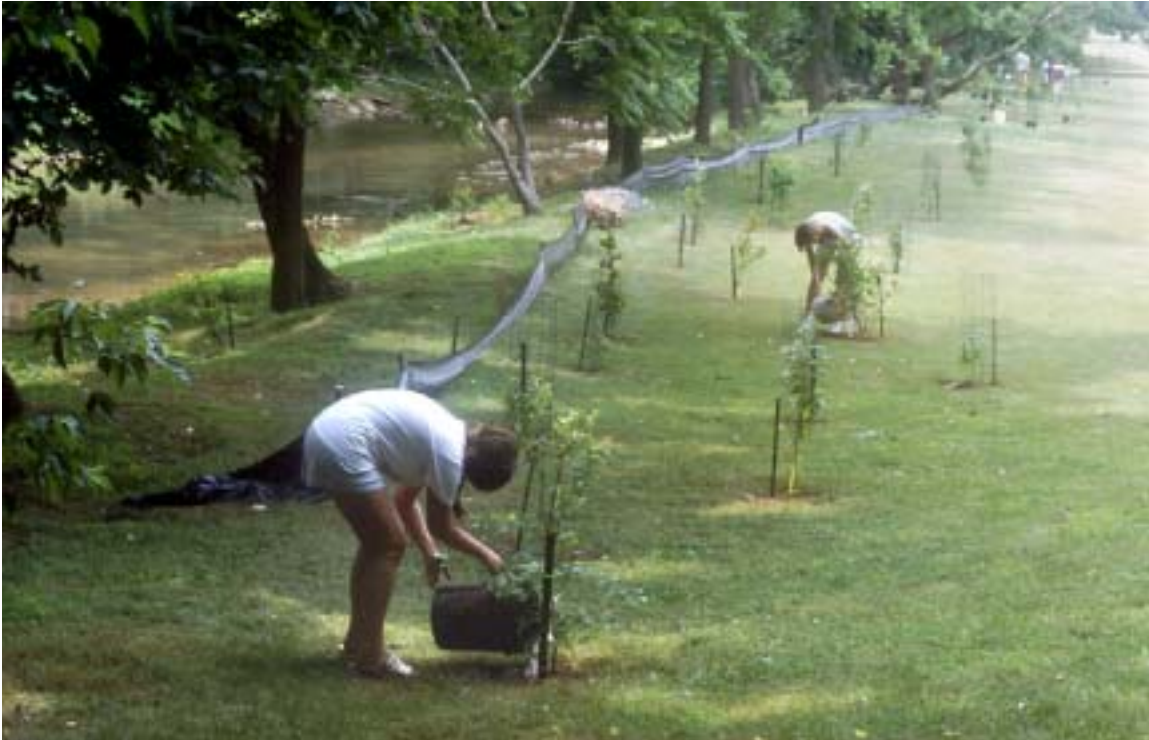
Figure 10 – A total of 39 dedicated volunteers assisted in the planting of 240 native trees, shrubs and herbaceous material. Vegetation along stream banks minimizes soil erosion and provides shade to the stream, maintaining the cool stream temperatures essential to fish and aquatic insects. Stream bank vegetation also serves as a buffer, offering habitat for wildlife and protecting the stream from the negative impacts of land uses such as agriculture and development.
