**Stream Restoration of Monocacy Creek at Route 512**

**2001**

**Wildlands Conservancy**

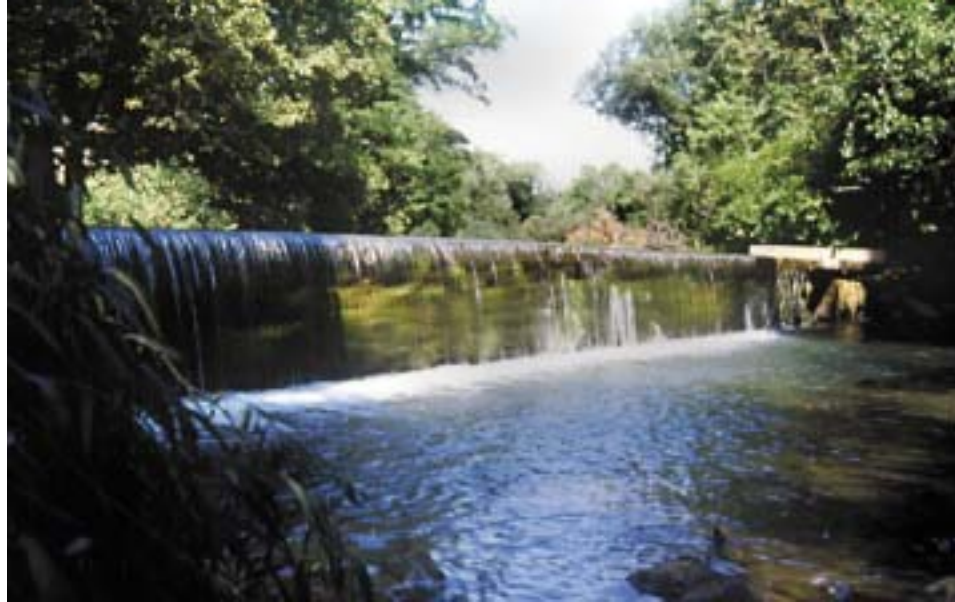
Figure 1. The low-head dam that is located immediately downstream of the project site has impacted the water quality and aquatic habitat of the Monocacy Creek.

A low-head, run-of-the-river dam located downstream from the Route 512 bridge is the primary cause of impairment to this section of the Monocacy Creek (Figure 1). This dam has reduced stream flow, accelerated erosion of the upstream banks, increased stream width and accelerated the deposition of fine sediment throughout the upstream channel. Mowing stream banks, feeding waterfowl by the public, and the excessive grazing of vegetation by waterfowl have also accelerated stream bank erosion throughout the project site.

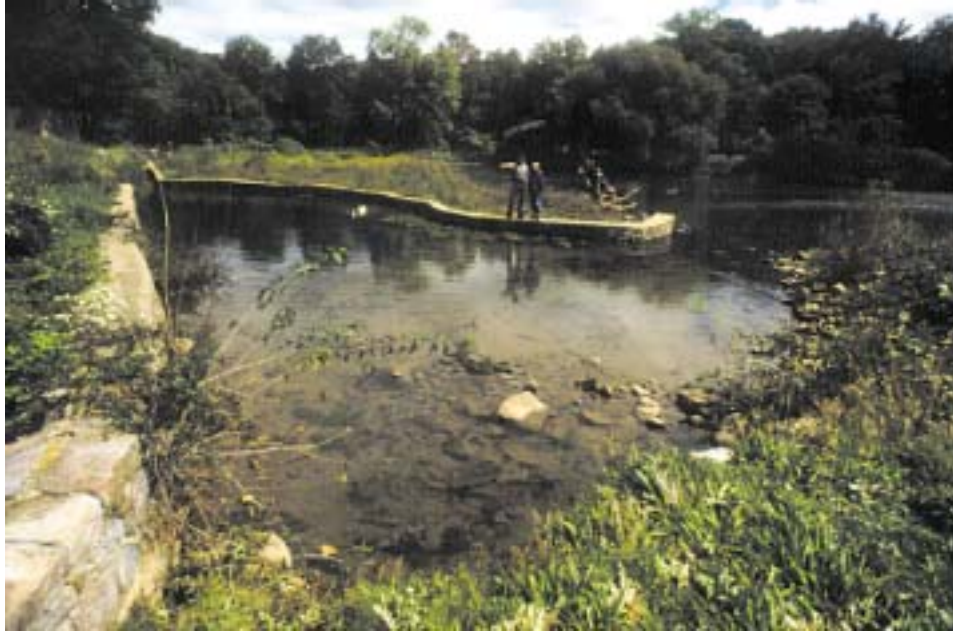
Figure 3. In addition to establishing a riparian buffer and constructing stream improvements, the project included the restoration of a historical spring raceway that empties into the Monocacy Creek. Note the riparian vegetation present after a “no-mow” management style was implemented as a preliminary, short-term recommendation until implementation of the project.

In September 2000, A-1 Construction, Inc. completed the restoration of the existing spring raceway (Figures 3-6). The scope of the raceway restoration consisted of the construction of a stone retaining wall, designed to narrow the existing raceway, thereby enhancing the flow and maintaining the temperature of the groundwater spring that discharges into the Monocacy Creek. The retaining wall was also constructed to provide bank stabilization while complementing the existing historic stone wall. Upon completion of the retaining wall, the area behind the wall was back-filled with stone and topsoil, seeded with a transitional native conservation seed mixture, stabilized with straw and planted with native shrubs.

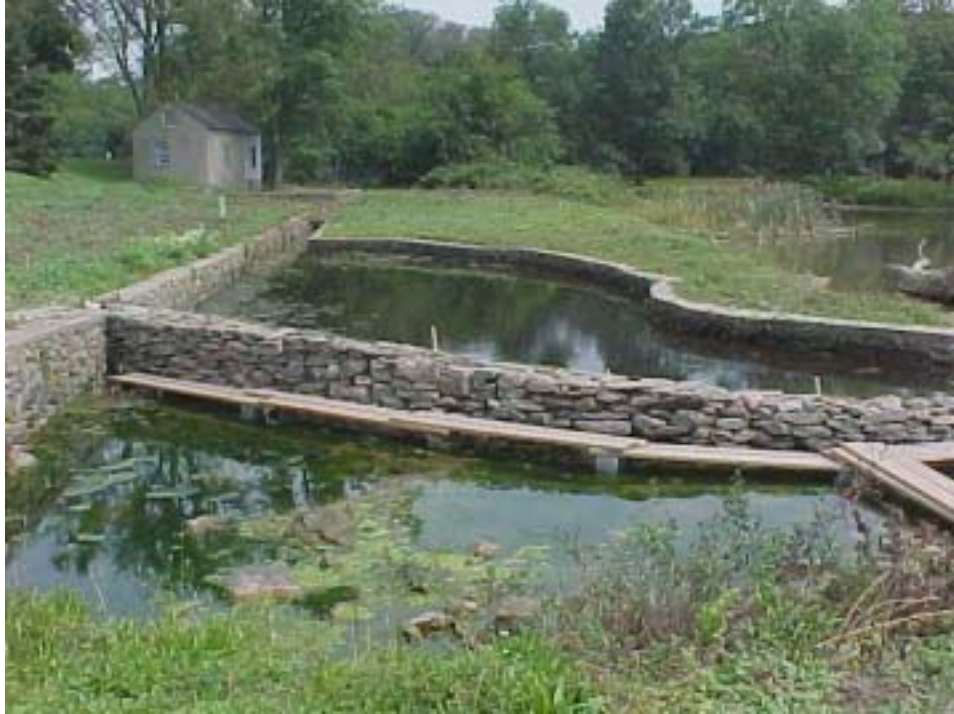
Figure 4. The spring raceway improvements were designed to provide stream bank stabilization and an enhanced cold water flow into the Monocacy Creek. A hand furnished stone wall was constructed to maintain the historical appearance of the property, while accomplishing these objectives.

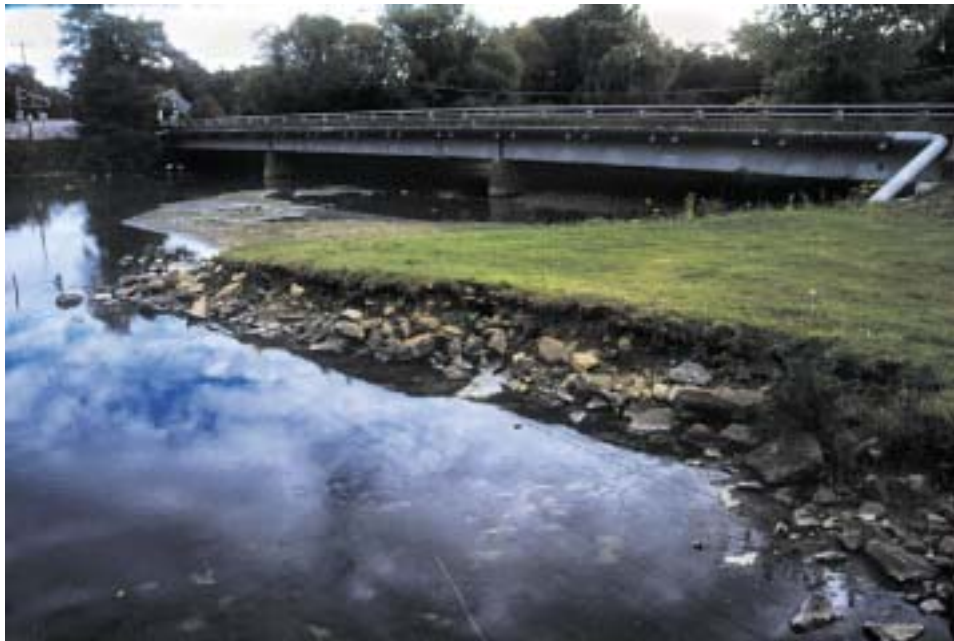
Figure 5. Mowing and waterfowl grazing of riparian vegetation has accelerated stream bank erosion adjacent to the spring raceway.

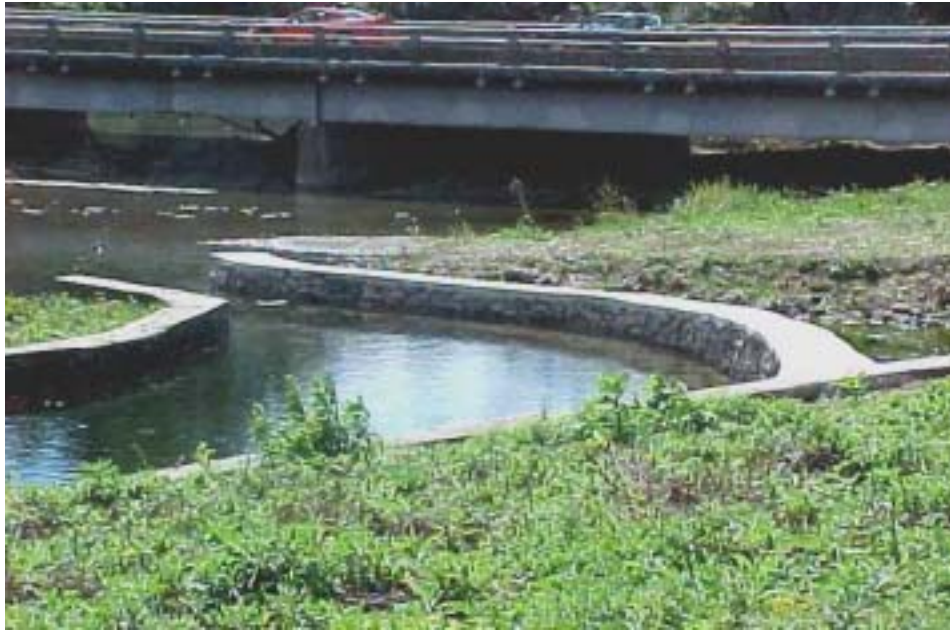
Figure 6. The area immediately behind the wall was back filled with stone and soil to provide a medium for the establishment of native trees, shrubs and grasses.

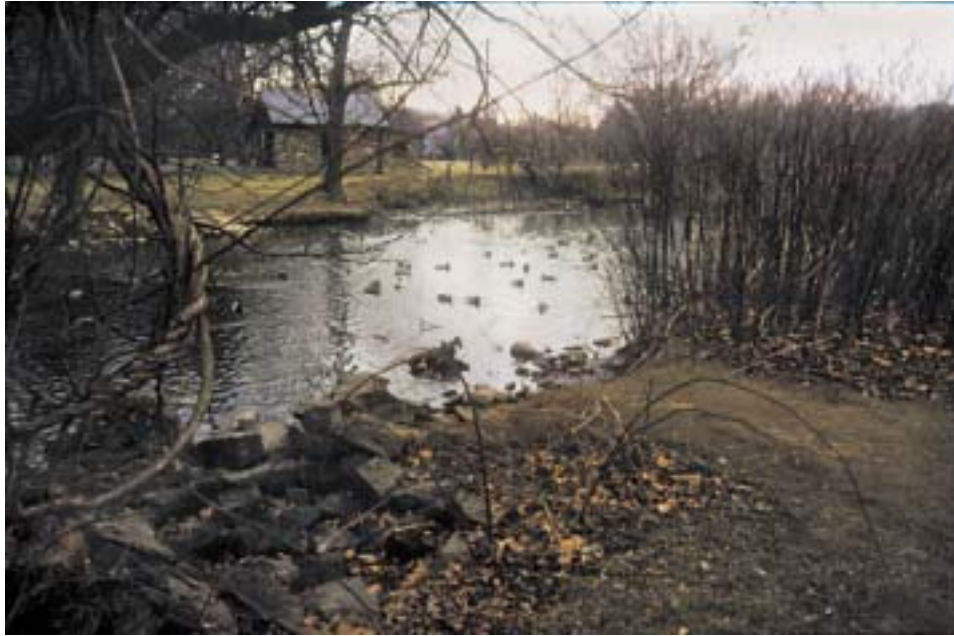
Figure 7. Mowing, grazing and continual trampling of the stream banks by waterfowl contributed to the stream bank erosion that was occurring along the project site.

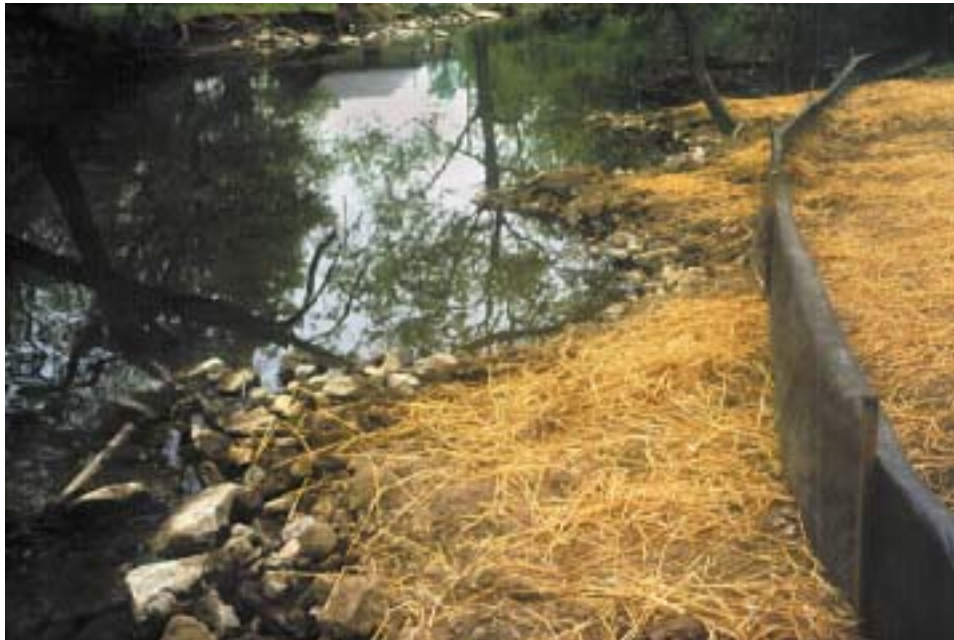
Figure 8. Saw-tooth deflectors were constructed to provide stream bank stabilization and improved aquatic habitat. A layer of topsoil was placed over the deflectors to provide a medium for the establishment of native vegetation.

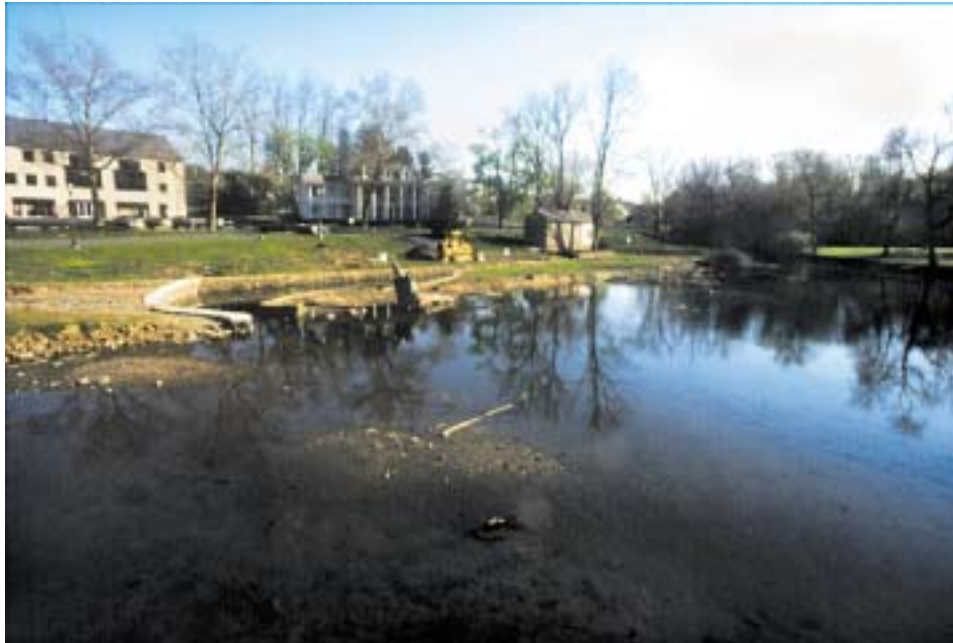
Figure 9. A view looking upstream at the project site from Route 512, immediately prior to the construction of stream improvements and the establishment of a riparian buffer.

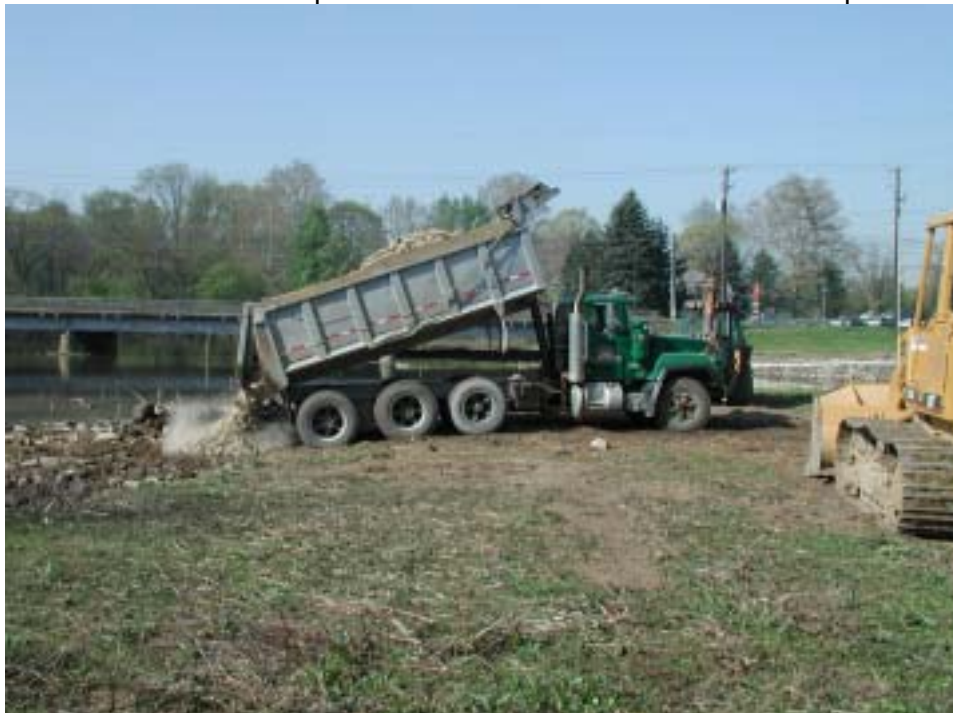
Figure 10. Approximately 600 tons on stone were used to construct the stream improvement devices, which consisted of one stone and three saw-tooth deflectors.

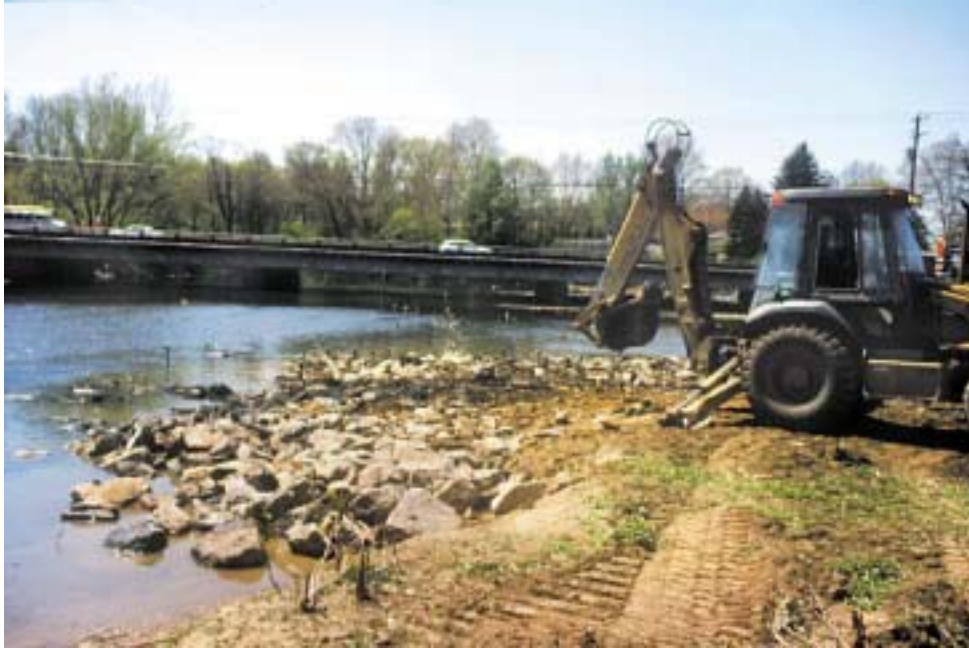
Figure 11. A backhoe was used to construct the stone and saw-tooth deflectors. The deflectors were constructed using mixed sizes of stone, and were dressed with layers of topsoil to provide a medium for the establishment of native trees, shrubs and grasses.

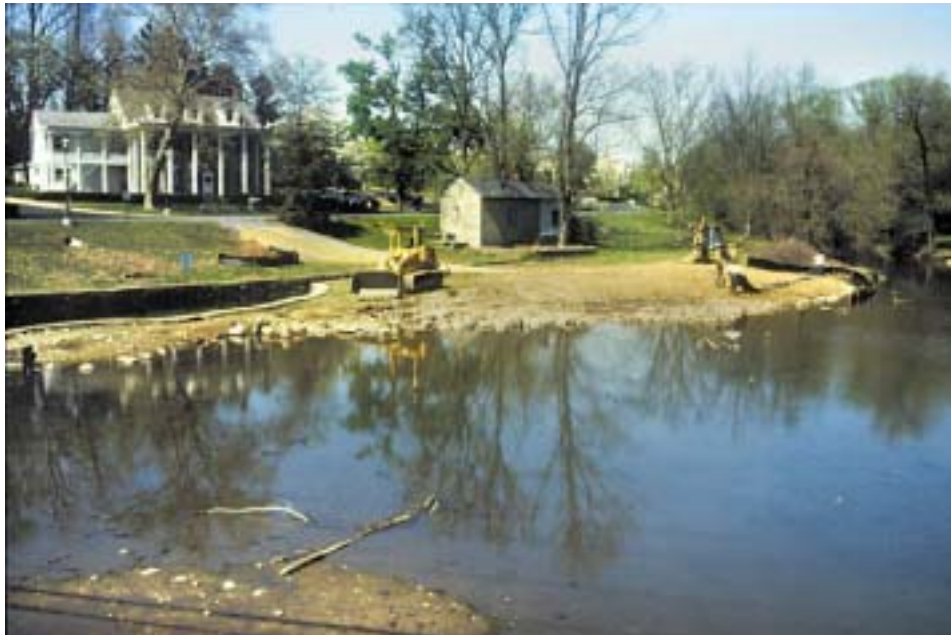
Figure 12. A view looking upstream at the project site from Route 512, after two days of excavation work on the stone deflector had been completed.

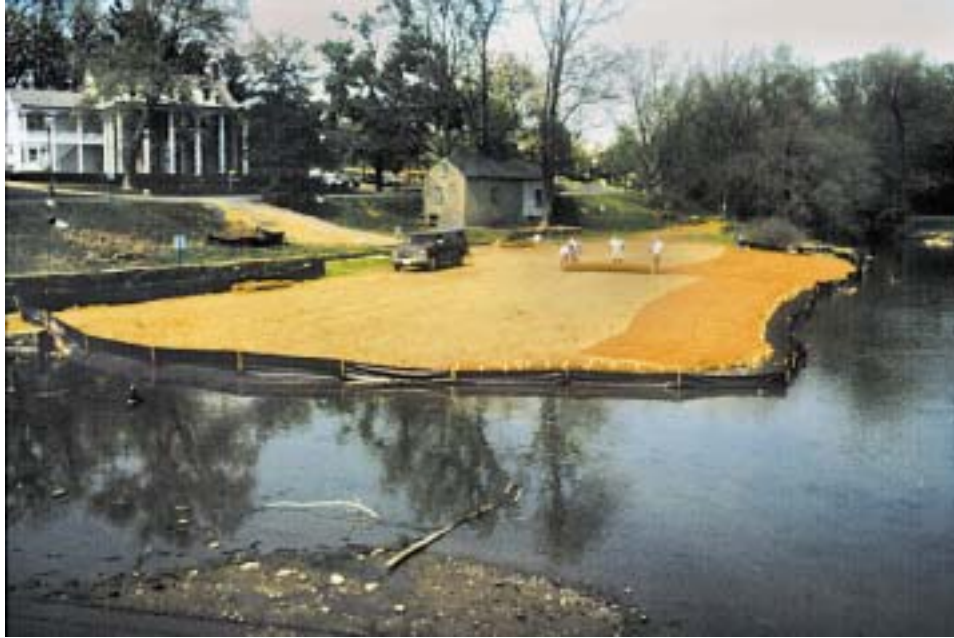
Figure 13. Silt fencing was erected around the perimeter of the deflector to prevent sediment from entering the stream during and prior to construction. Upon completion of the deflector, native wetland, transitional and upland seed mixtures were applied to the soil. Biodegradable coconut blanket and straw mulch was used to provide soil stabilization and to promote vegetative growth.

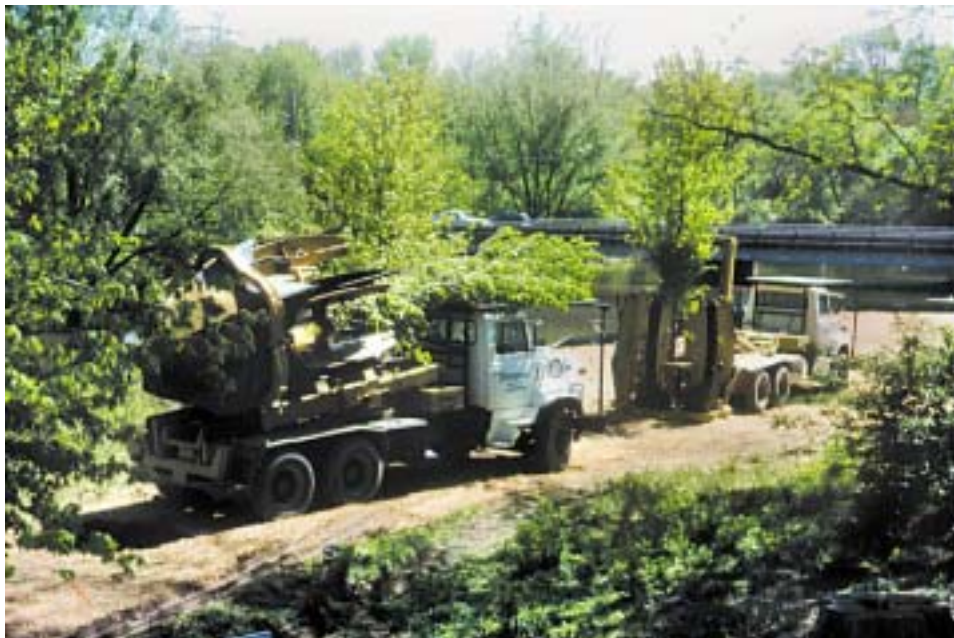
Figure 14. Seven 5" caliper red maple trees were planted to establish a transitional zone between the project site and the Gertrude Fox Conservation Area. This would allow for the "blending" of the project into the natural landscape.

Greentree Nurseries, Inc. used a tree spade system to deliver and plant seven red maple (*Acer rubrum*) trees within the floodplain area adjacent to the

deflectors. These red maples (15-20 feet in height, 4½-5 inches in caliper) were used to establish a transition in the height of plant material between the project site and the Gertrude Fox Conservation Area, a forested stream corridor located immediately adjacent to and upstream of the project site.

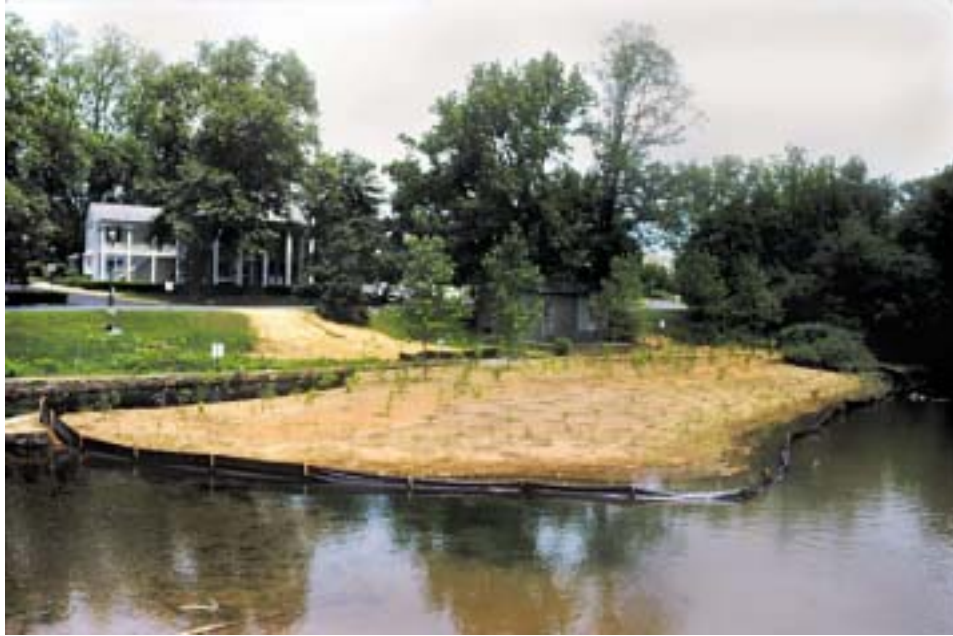
Figure 17. An upstream view of the project site immediately following the construction of stream improvements and the establishment of a riparian buffer.
