**LITTLE LEHIGH CREEK HYDRO-MODIFICATION,
STREAMBANK RESTORATION, HABITAT IMPROVEMENT
AND RIPARIAN PLANTING PROJECT**

July 2000

Wildlands Conservancy

Funding Provided By:
PA Department of Environmental Protection
Watershed Restoration and Assistance Program

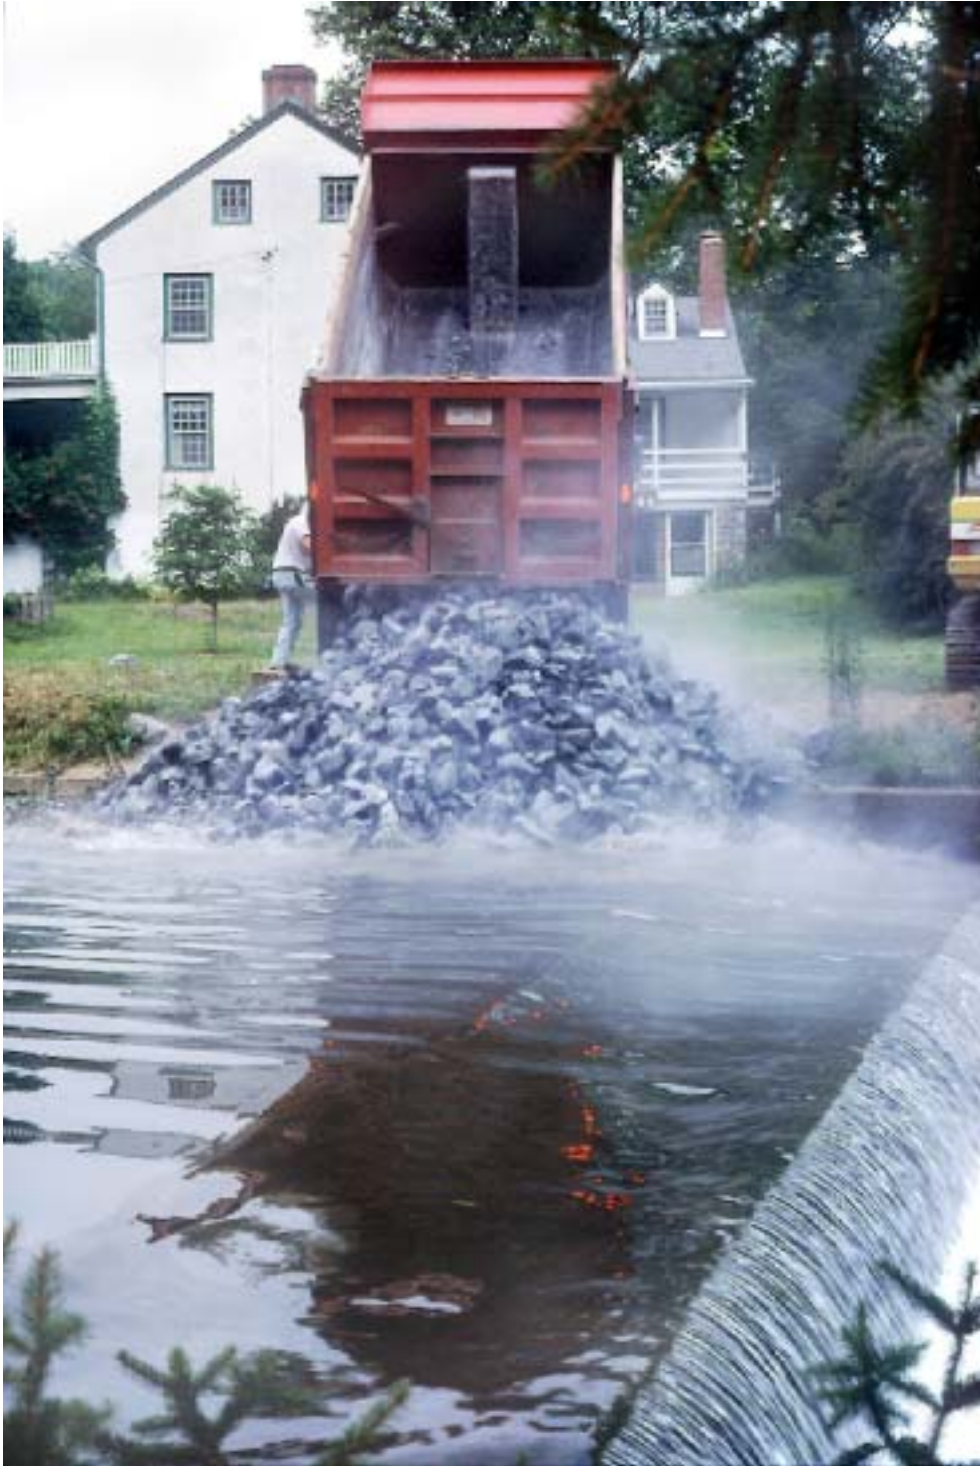
Figure 2. The stone that was used during the project was purchased and delivered from a local limestone quarry. Suitable access to the dam existed along the left streambank (looking downstream).

Flyway Excavating, Inc. arrived at Wildlands Conservancy to begin project implementation. Limestone riprap was purchased from a local quarry and hauled to the project site. The dam was accessed from the left stream bank and a staging area was prepared for equipment and machinery. Stone riprap was dumped along the left stream bank upstream of the dam (Figure 2), and a causeway was fashioned (Figure 3). This causeway was used to provide equipment access to the length of the concrete dam and a portion of the opposite stream bank.

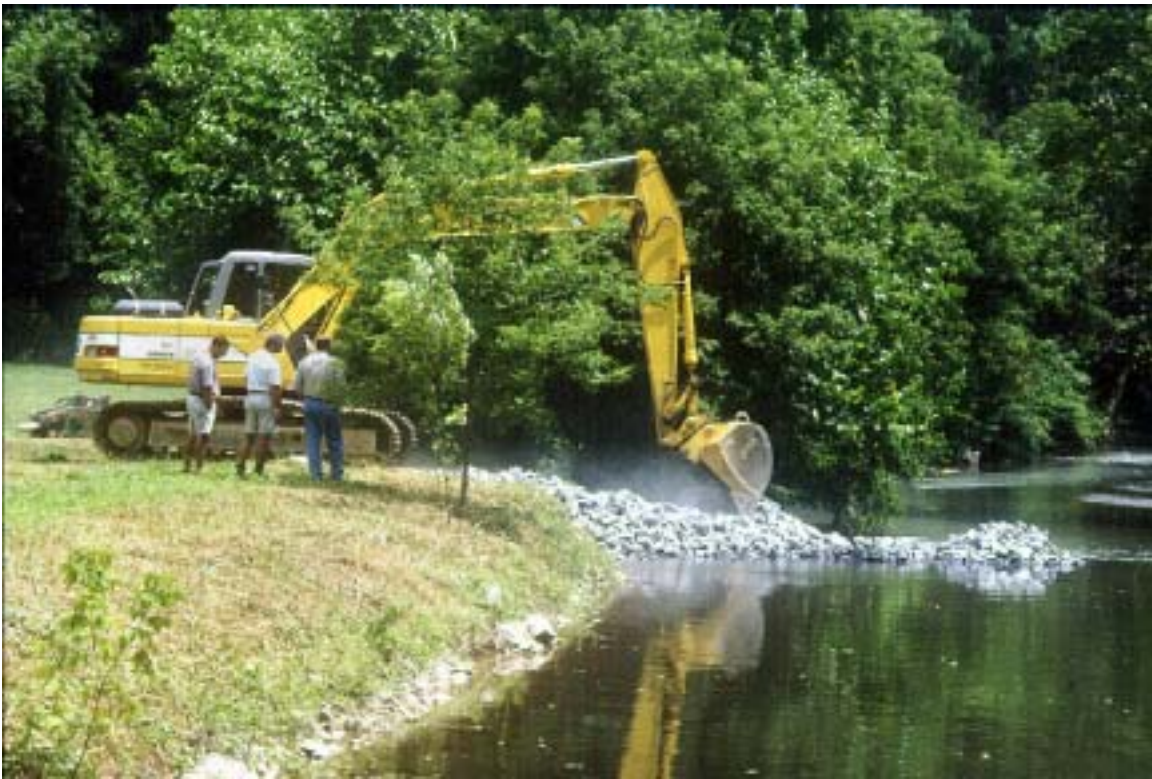
Figure 3. The equipment operator created a stone causeway to access the entire length of the concrete dam and a portion of the opposite streambank.

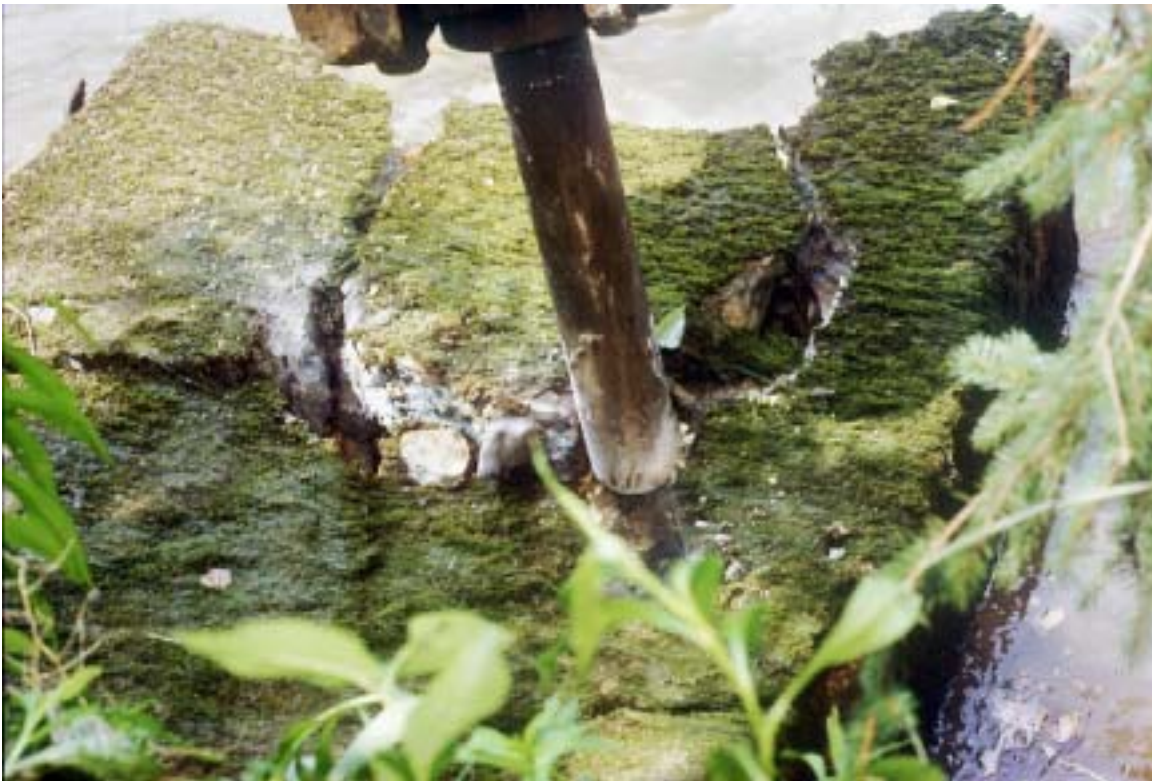
Figure 5. Portions of the concrete dam were broken into pieces that were manageable and easily manipulated.

Once access was established, a hydraulic jackhammer was attached to the track hoe. After positioning the track hoe on the causeway, the jackhammer was used to puncture the concrete dam breast (Figure 5). A bucket was attached to the track hoe to remove portions of concrete that had been broken (Figure 6). This removal of broken material would create a notch in the dam breast of approximately ten feet wide. Manipulating the notch size controlled the rate of water draw down (Figure 7).

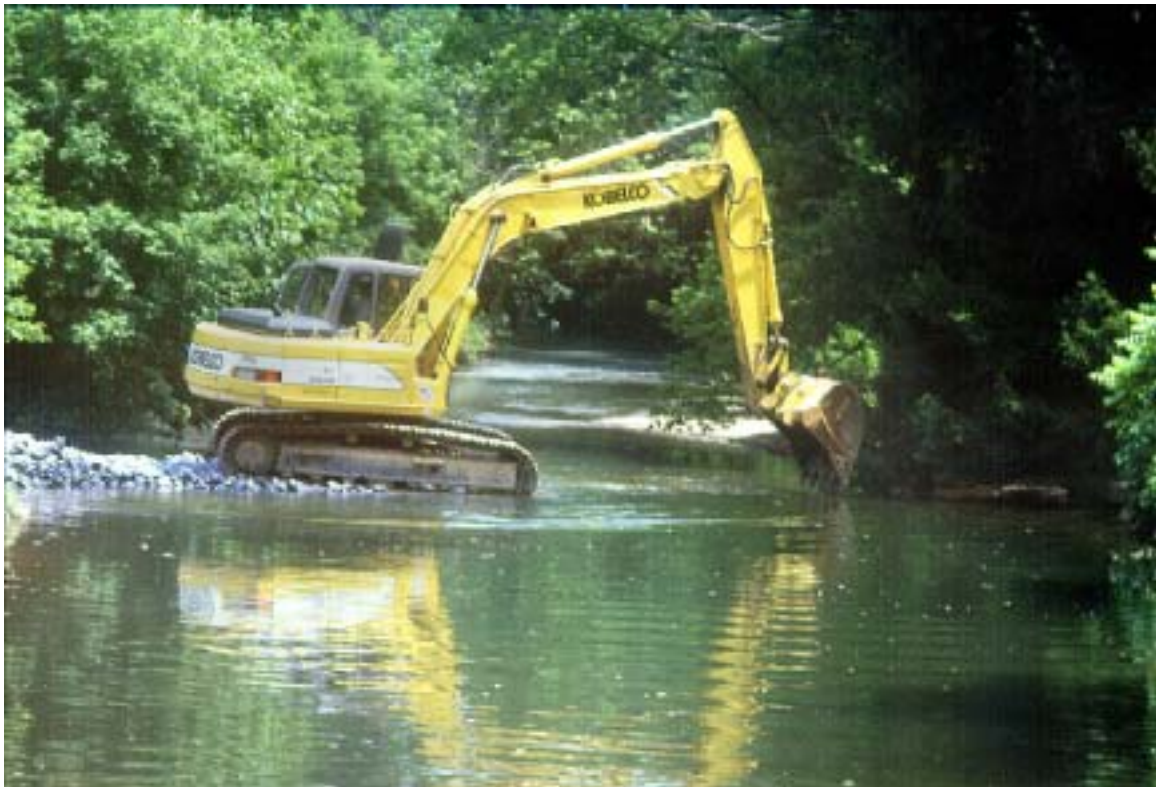
Figure 6. Once the hydraulic jackhammer was used to puncture the dam, the concrete was removed to create a notch in the dam breast on the far bank.

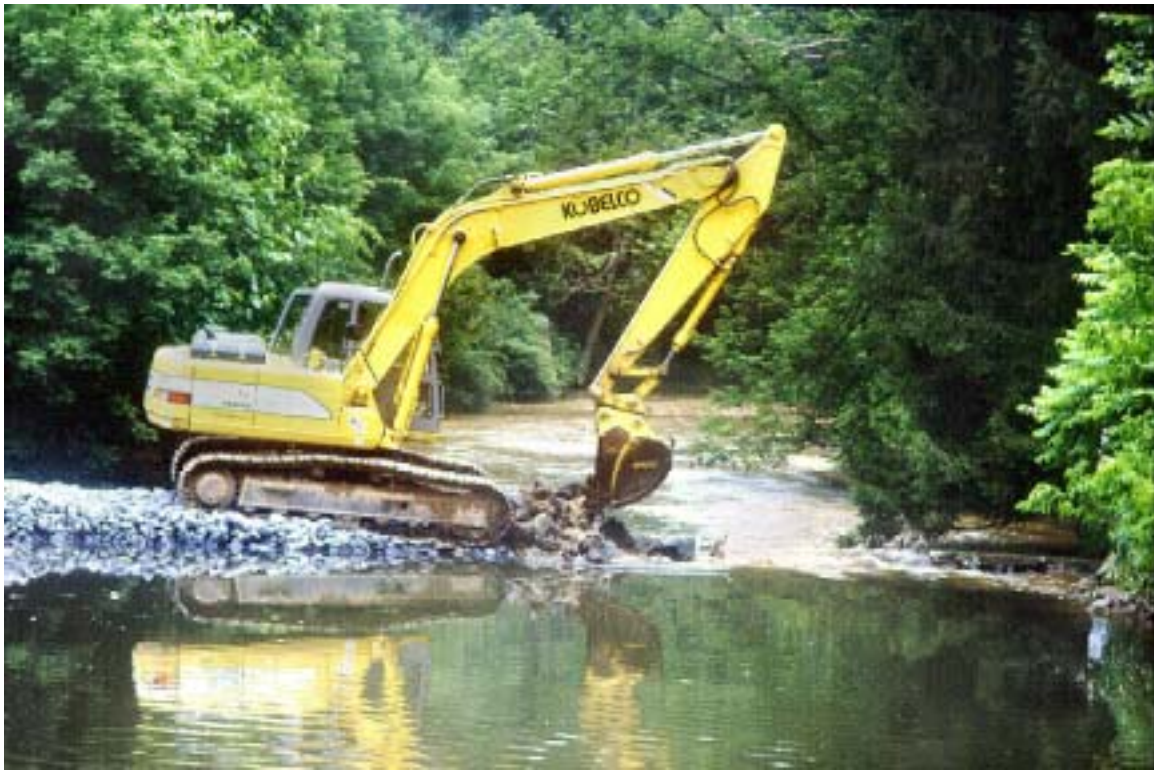
Figure 7. An appropriate rate of water draw down was established by regulating the size of the notch.

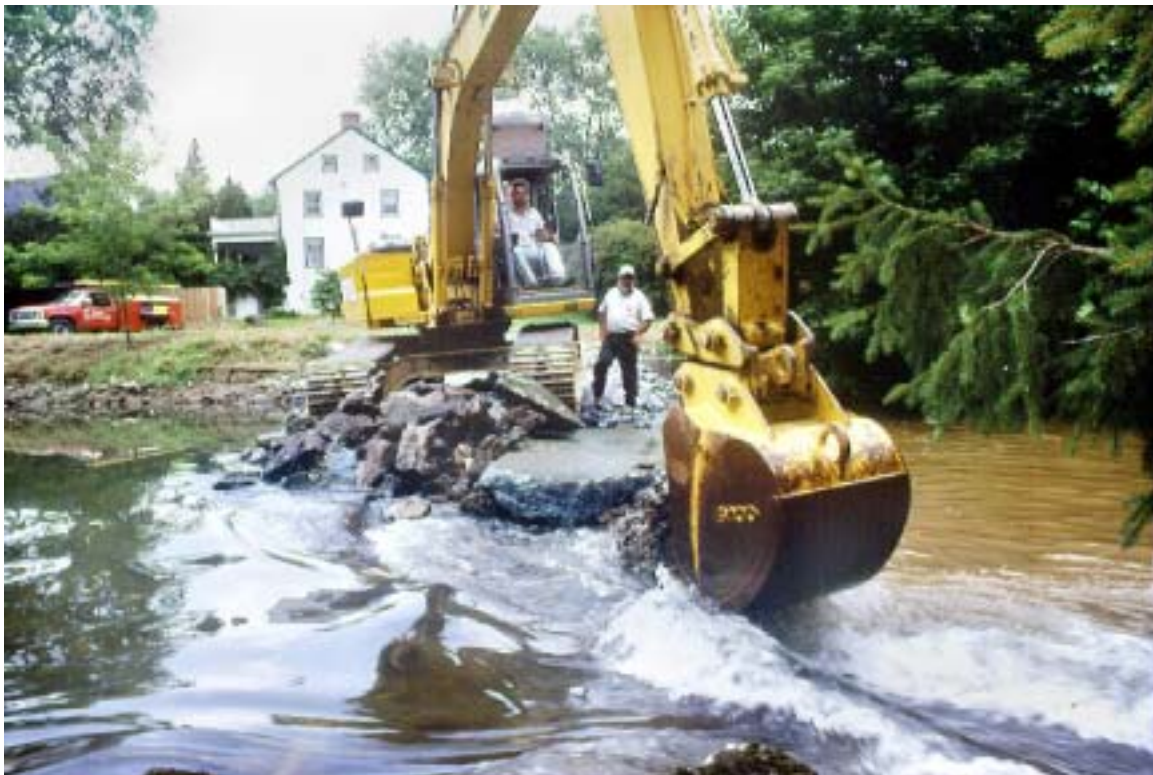
Figure 8. Once the initial dam breach was completed, concrete was continually removed to increase the size of the notch.

Once the initial draw down had occurred, concrete was continually removed from the dam breast to enlarge the notch, allowing for continued draining of the water upstream of the dam (Figure 8). To assess the condition of the breach and allow a controlled draw down, excavation was paused periodically (Figure 9). This process would be repeated over the course of approximately two to three days until the entire dam breast was removed. Once the dam removal phase of this project was completed, the stone used in constructing the causeway was removed from the stream channel and used to stabilize the near stream bank (Figure 14).
