**TRIBUTARY TO MONOCACY CREEK
STREAM RESTORATION PROJECT**

July 2000

Wildlands Conservancy

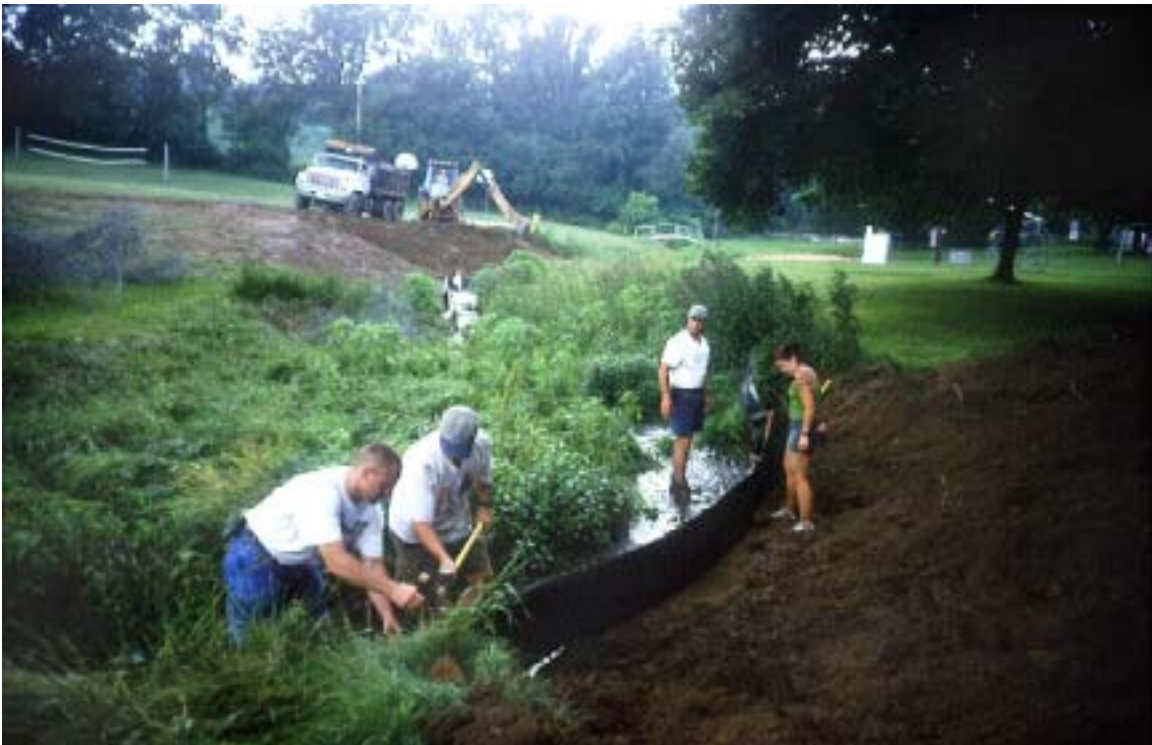
Figure 10. Bank erosion was most severe along stream banks that were situated along the outside of meander bends. Shallow rooted grasses offer little stabilization value. These banks would require more intensive techniques to stabilize and revegetate.

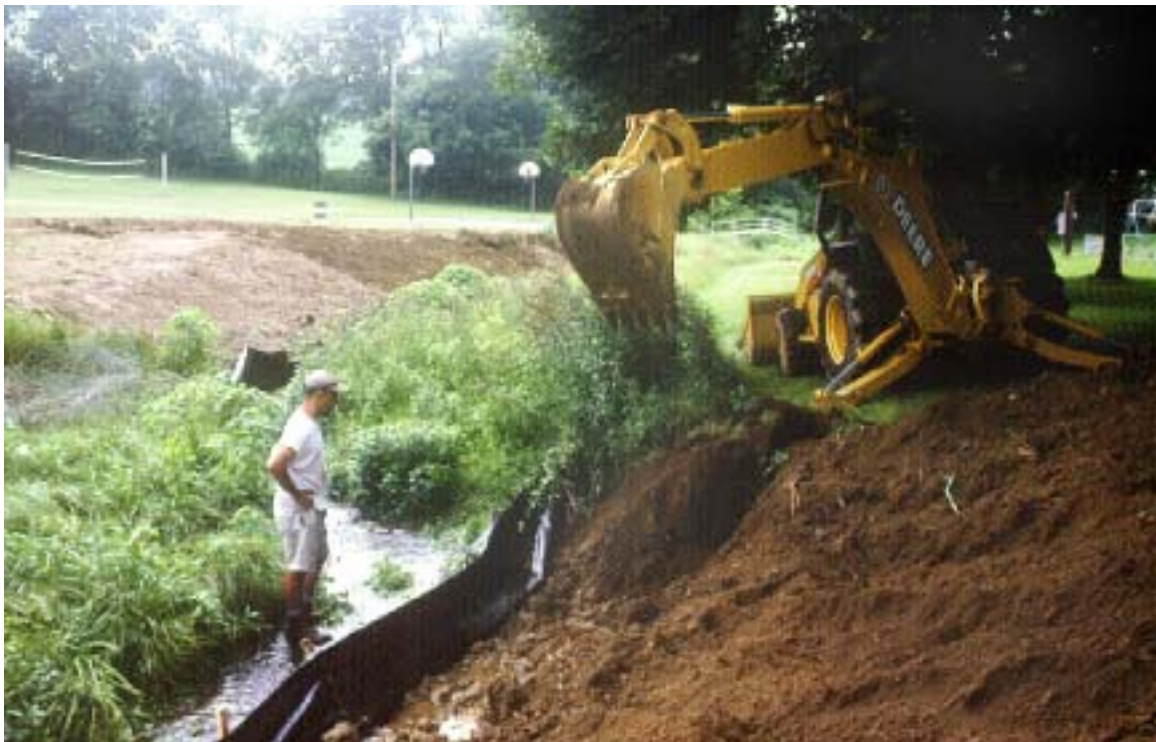
Figure 11. The availability of multiple excavators allowed for simultaneous bank work, which was necessary for the timely completion of this project.

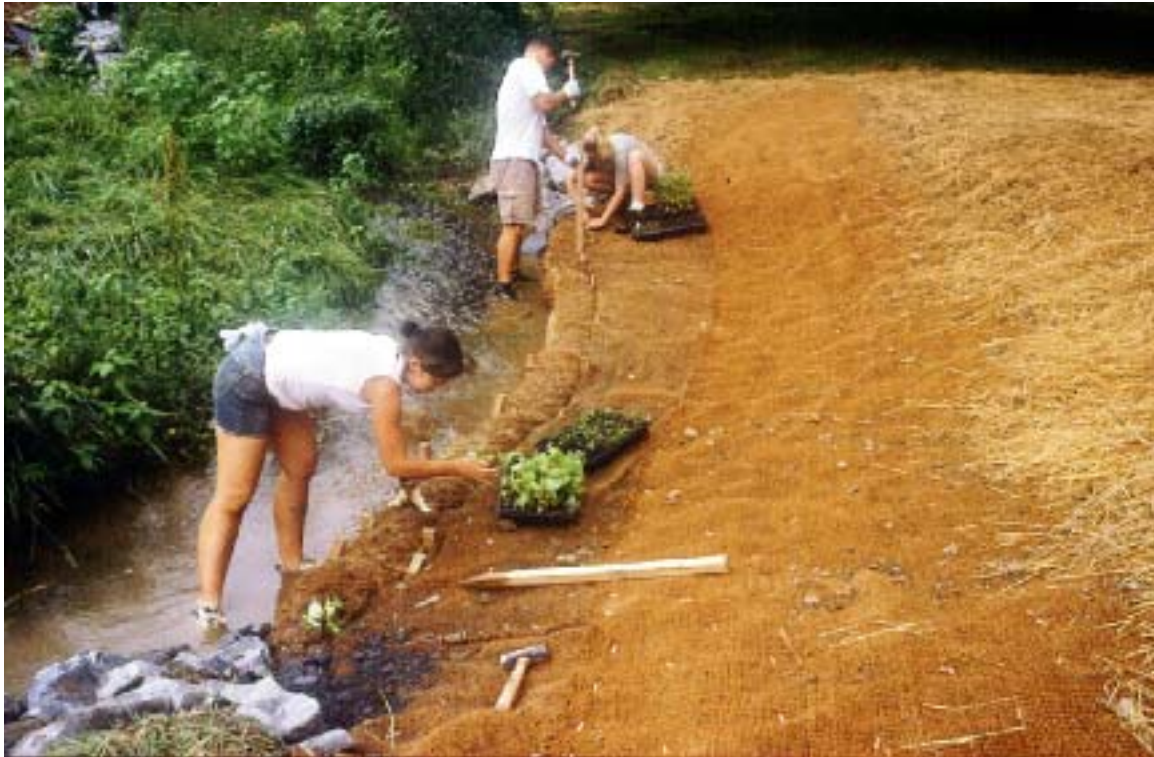
Figure 12. Communication with equipment operators is essential in assuring that restoration techniques are implemented to design specifications.

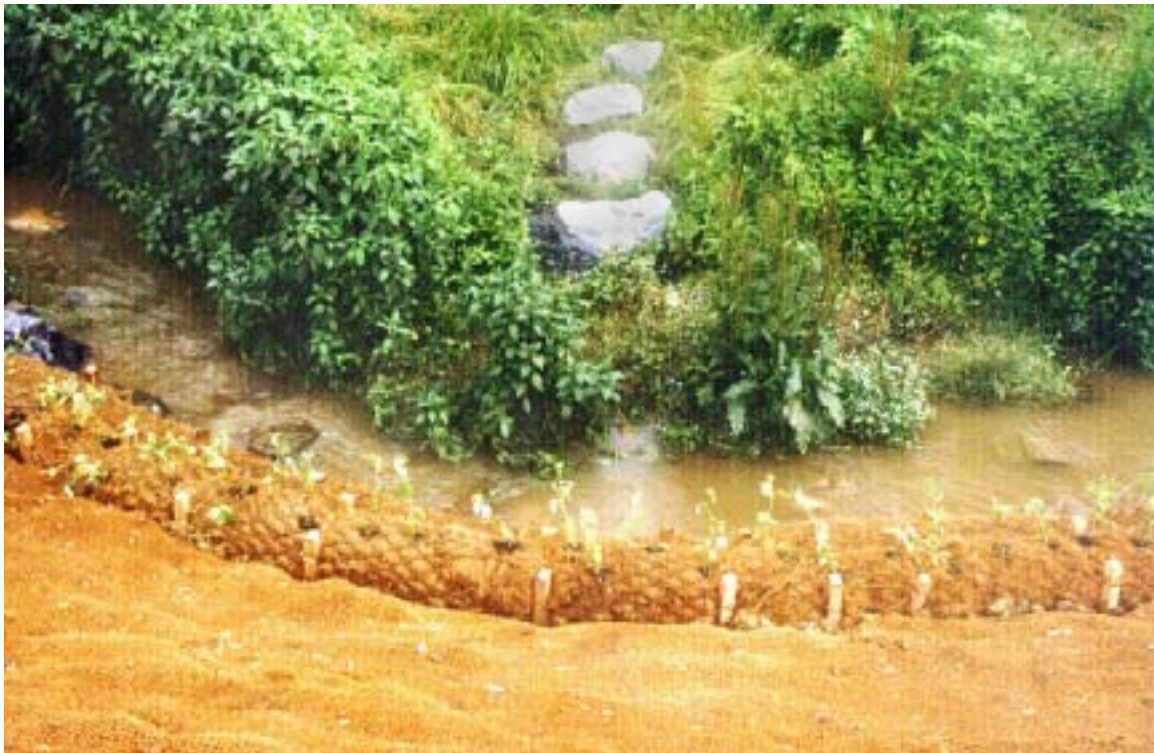
Figure 14. Natural materials were incorporated into the restoration design where appropriate. The use of coconut coir logs allowed for vegetated toe stabilization that would mimic the natural contours of the stream.
